# ANALYSIS OF THE DYNAMICS OF COASTAL LANDFORM CHANGE BASED ON THE INTEGRATION OF REMOTE SENSING AND GIS TECHNIQUES: IMPLICATIONS FOR TIDAL FLOODING IMPACT IN PEKALONGAN, CENTRAL JAVA, INDONESIA

Remote Sensing Application Centre, Indonesian National Institute of Aeronautics and Space (LAPAN), Jakarta, Indonesia

**KEY WORDS:** Coastal landform, tidal flooding, remote sensing – GIS, Pekalongan, Central Java, Indonesia

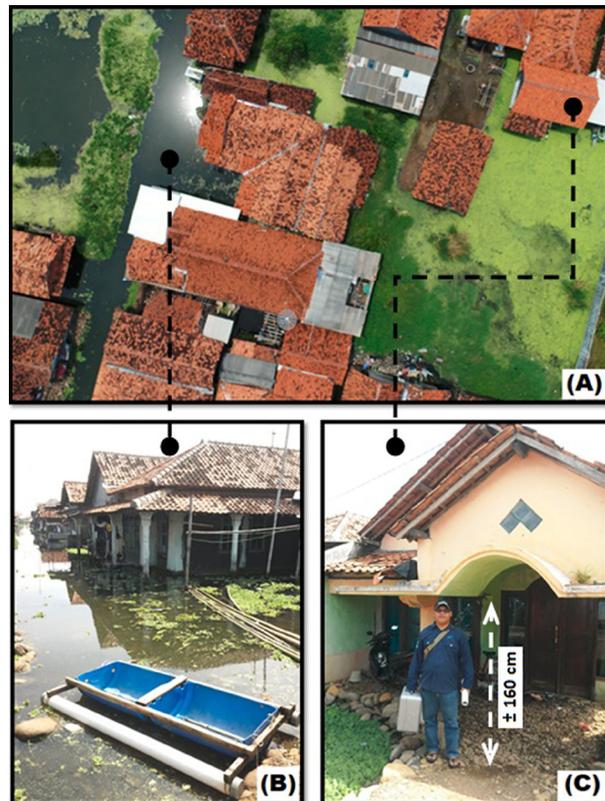
Fig. 1. Environmental conditions in one of the locations affected by tidal flooding in Mulyorejo Village, Tirto District, Pekalongan Regency. (Photos and drone mapping by Yulianto, 2017). A. Tidal flooding seen from a height of 50 m using drone mapping; B. Non-functioning road infrastructure and inundated houses; C. Community adaptation efforts in dealing with the impact of tidal floods by piling up soil, sand and stone in the yard of a house.

Pekalongan is located in the coastal area of Central Java, Indonesia. The dynamics of the development of coastal landforms in the area are extensive and rapidly changing as a result of land use requirements (Ismail 2012). Tidal flooding (known locally as *rob*) is one of the phenomena that impact on environmental, social and economic conditions in coastal areas of Pekalongan. These occurrences make economic facilities, infrastructure and public health failure to be operated. It also degraded prices for land and housing as well as increasing poverty, unemployment, dirty and slum environments. In addition, according to Marfai (2014), other areas affected by tidal flooding in coastal Pekalongan includes mangrove ecosystems, agriculture and aquaculture, and these impacts have become widespread due to rising sea levels. Figure 1 shows the impact of tidal flooding on environmental conditions and inadequate road infrastructure as a result of tidal flooding in Mulyorejo Village, Tirto District, Pekalongan Regency.

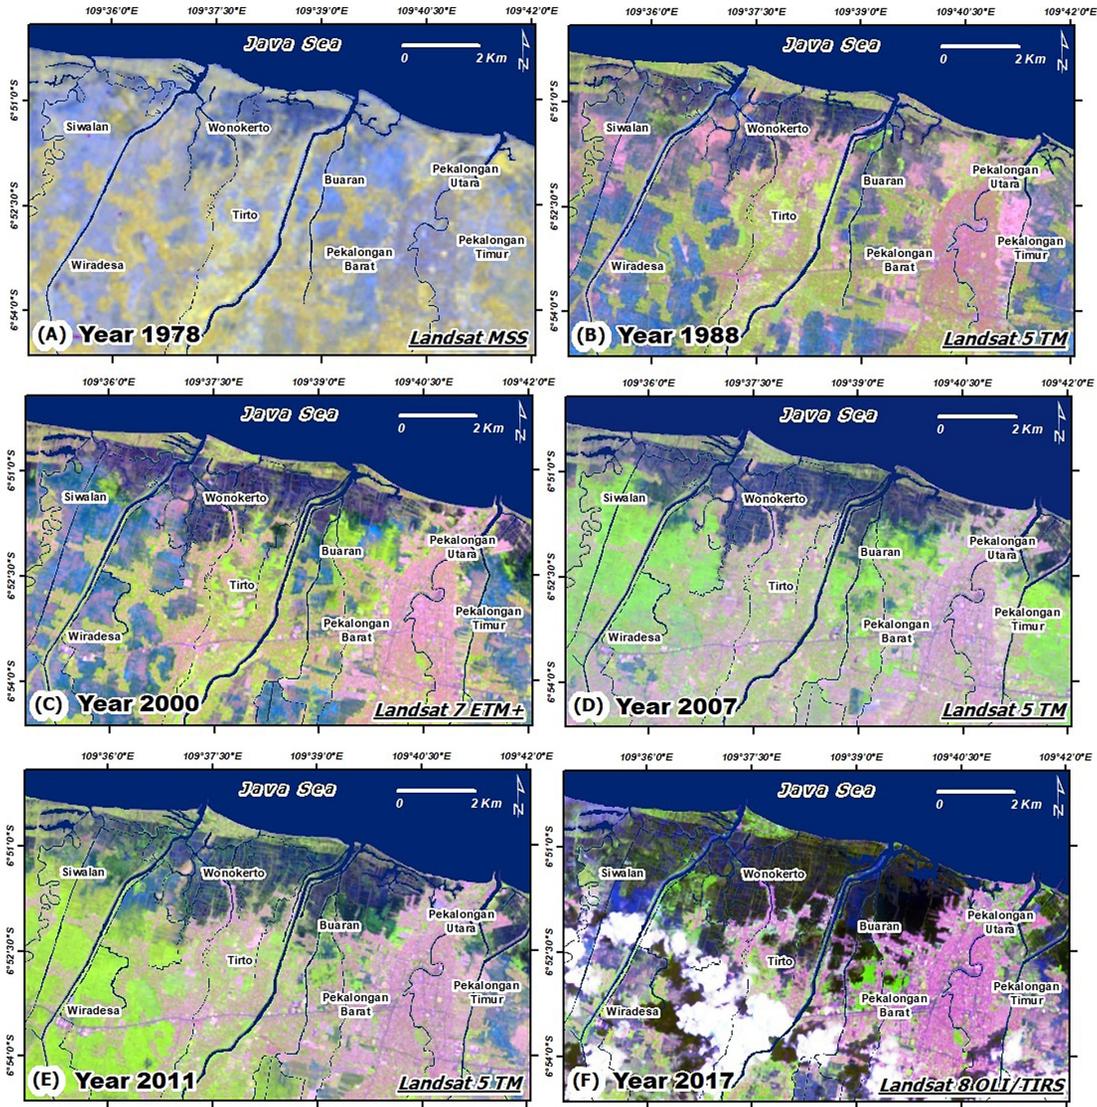
Fig. 2. Landsat images were used to perform coastal landform mapping, consisting of analysis of multi-temporal changes in morphology for 1978 to 2017 in the study area.  
 A. Landsat MSS 1978; B. Landsat 5 TM 1988; C. Landsat 7 ETM+ 2000; D. Landsat 5 TM 2007; E. Landsat 5 TM 2011; F. Landsat 8 OLI/TIR 2017.

The coastal landform mapping was prepared based on visual and digital interpretation of Landsat images. The estimation of coastal landform features was performed using an on-screen digitizing approach for Landsat image colour

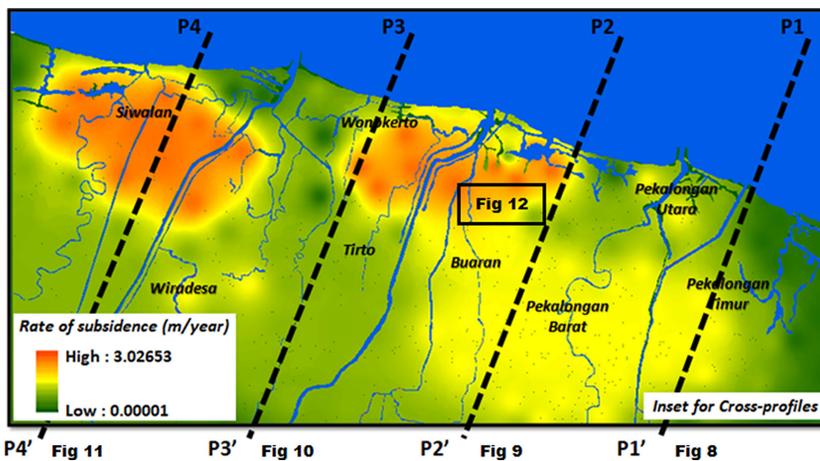
Fig. 3. The rate of subsidence ( $3 \text{ cm yr}^{-1}$  on average) was obtained based on research by Nashrullah et al. (2013). Inset are locations for Fig. 8, 9, 10, 11, and 12.

Topographic conditions in the study area can be represented and simplified using the digital elevation model (DEM), which was created using high-point data from the topographic map at scale 1:25,000, obtained from BIG. The data provides high-point information for 1998 spread evenly across the study area. A high-point interpolation approach using inverse distance weighted for 30 × 30 m was used to create DEM mapping of the study area. Furthermore, topography or DEM current (2017) and previous-year (1978, 1988, 2000, 2007 and 2011) conditions can be modelled using Equation (1) as in previous research by, for example, Marfai and King (2007) and Ward et al. (2010). Rate of subsidence is also needed for DEM modelling and in this study this rate (3 cm yr<sup>-1</sup>) on average (Fig. 3) was obtained based on the research carried out by Nashrullah et al. (2013).

modelling as used by Marfai and King (2007) was implemented. The rate of subsidence (i.e. 3 cm yr<sup>-1</sup>) stated by Nashrullah et al. (2013) was used as a reference in this study. The modelling was assumed to be linear in every year, which means no action or treatment of subsidence issues took place in the study area. Marfai and King (2007) and Ward et al. (2010) have applied the method for monitoring land subsidence in Semarang and Jakarta, respectively. The same method was applied in this study because it has almost the same regional characteristics. Not only for monitoring and modeling land subsidence, but also this study was carried out aimed to trace and map historically the dynamics of topographical change. The results of the analysis from (Fig. 4) show that high-value DEM data (3.4 to 4.7 m above sea level from 1978 to 2017) show a relatively stable area and little effect on the problem of land subsidence. Meanwhile, low-value DEM data (–1.9 to –2.3 m above sea level in years 1978 to 2017) show the areas most influenced by land subsidence problems in the study area.

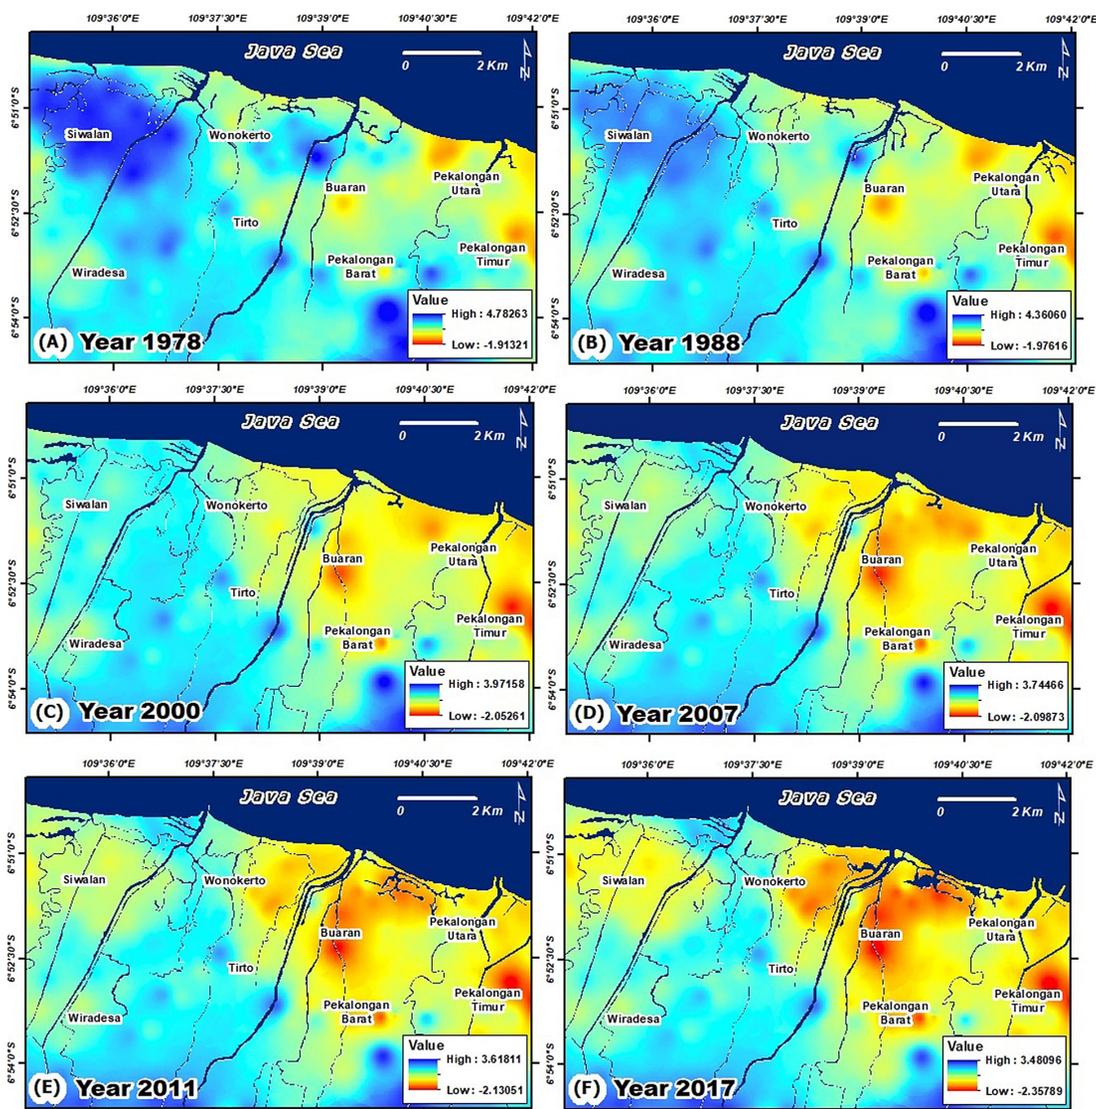
Fig. 4. The results of the dynamics of coastal topographical mapping and modelling for 1978 to 2017 in the study area.

In this study, topographic conditions can be represented and simplified using the DEM. The results of the dynamics of coastal topographical mapping and modelling from 1978 to 2017 in the study area are presented in Figure 4.

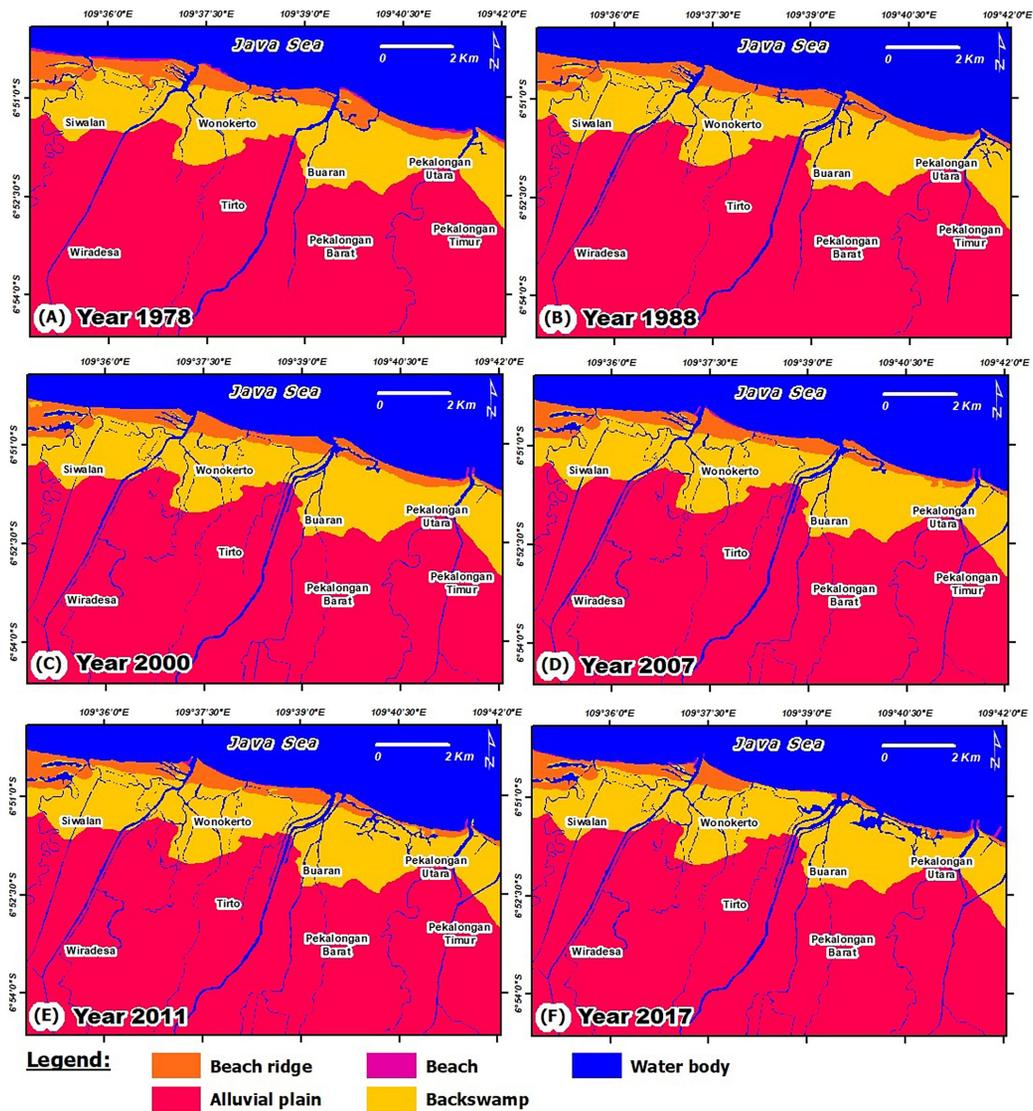
Fig. 5. The results of coastal landform mapping and change from 1978 to 2017 in the study area.

can be classified into four landform types: beach, beach ridge, backswamp and alluvial plain, based on visual and digital interpretation of Landsat colour composite images from 1978 to 2017. In addition, coastal landform classification can be complemented by parameters based on the field surveys and other spatial data, such as topography, relief, land use/land cover, soil and others. The elements of coastal landform classification and other parameters are presented in (Table 1), while the results of coastal landform mapping in the study area are presented in (Fig. 5). Based on the results of coastal landform mapping and change from 1978 to 2017, the estimated areas of coastal landform change for 1978 to 2017 in the study area are as presented in (Table 2) Meanwhile, the estimate of the average rate of coastal landform area change for 1978 to 2017 is presented in (Table 3).

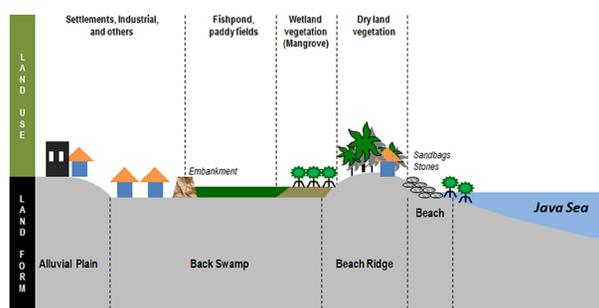
Fig. 6. The relationship between coastal landform profile and land use in the study area.

In general, the characteristics of the coastal landform profile in the study area are as presented in (Fig. 6). An example of the conditions of coastal landforms in the study area can be seen in (Fig. 7). In addition, coastal landform change can also be caused by the influence of land subsidence. The topographic modelling carried out in this research shows that the topographic changes caused by land subsidence have changed the coastal landform classes in several locations in

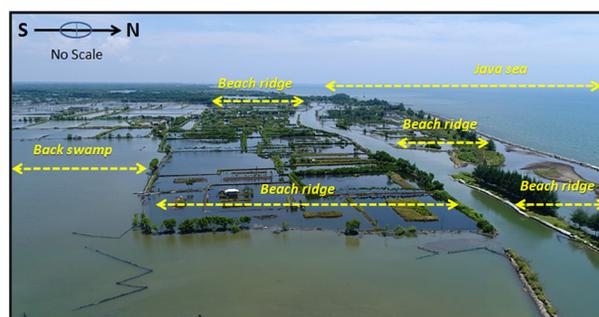
Fig. 7. Landform coastal conditions in 2017 in the study area. The beach ridge, which has an important role as a natural embankment in coastal areas, has been changed into a flat area and is used by local people for ponds (Photo: F. Yulianto 2017).

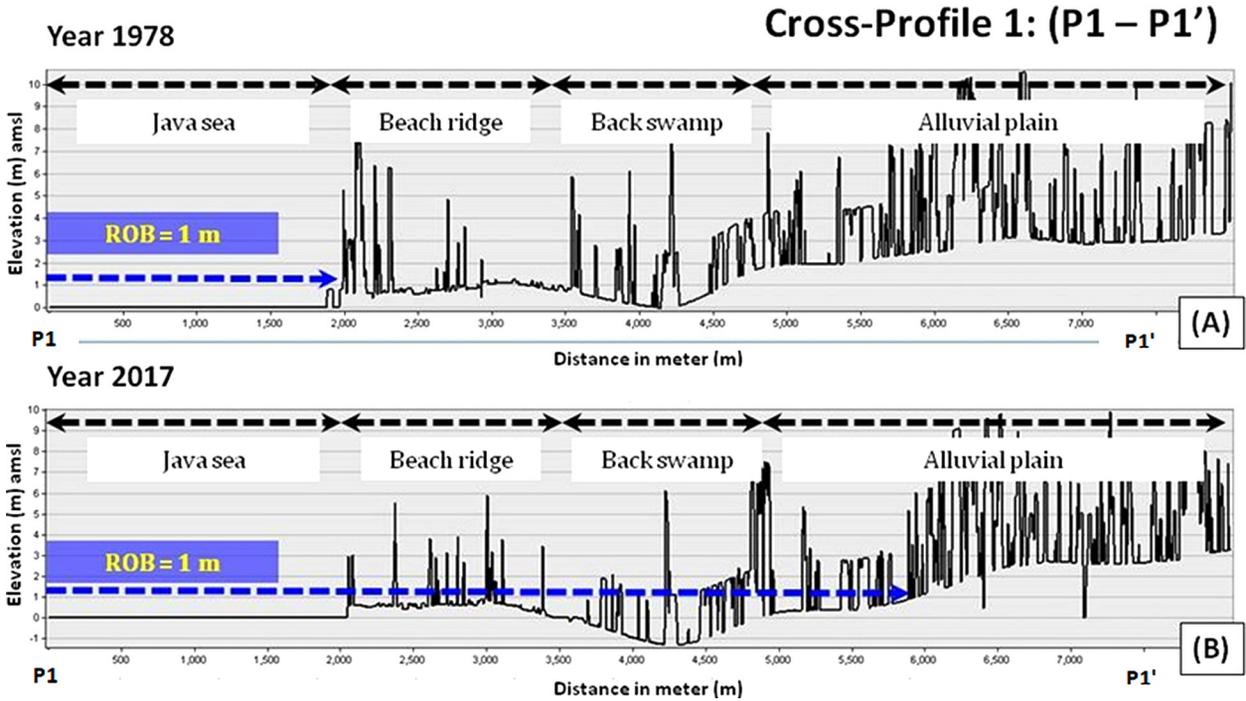
Fig. 8. Comparison results for morphological and topographic condition change from DEM modelling between 1978 and 2017 on cross-profile 1 (P1-P1') and their implications for vertical tidal flood distribution in coastal landform areas.

A. DEM cross-profile 1 in 1978; B. DEM cross-profile 1 in 2017.

presented in (Figs 8–11). It can be seen that beach ridges play an important role as natural dykes that serve to withstand flooding. In 1978 a tidal flood with a height of 1 m was retained by the beach ridge, while in 2017, with land subsidence having impacted on topography, 1 m flooding could not be restrained by the beach ridge and the flood tide was distributed across land areas by up to between 3 and 5 km inland.

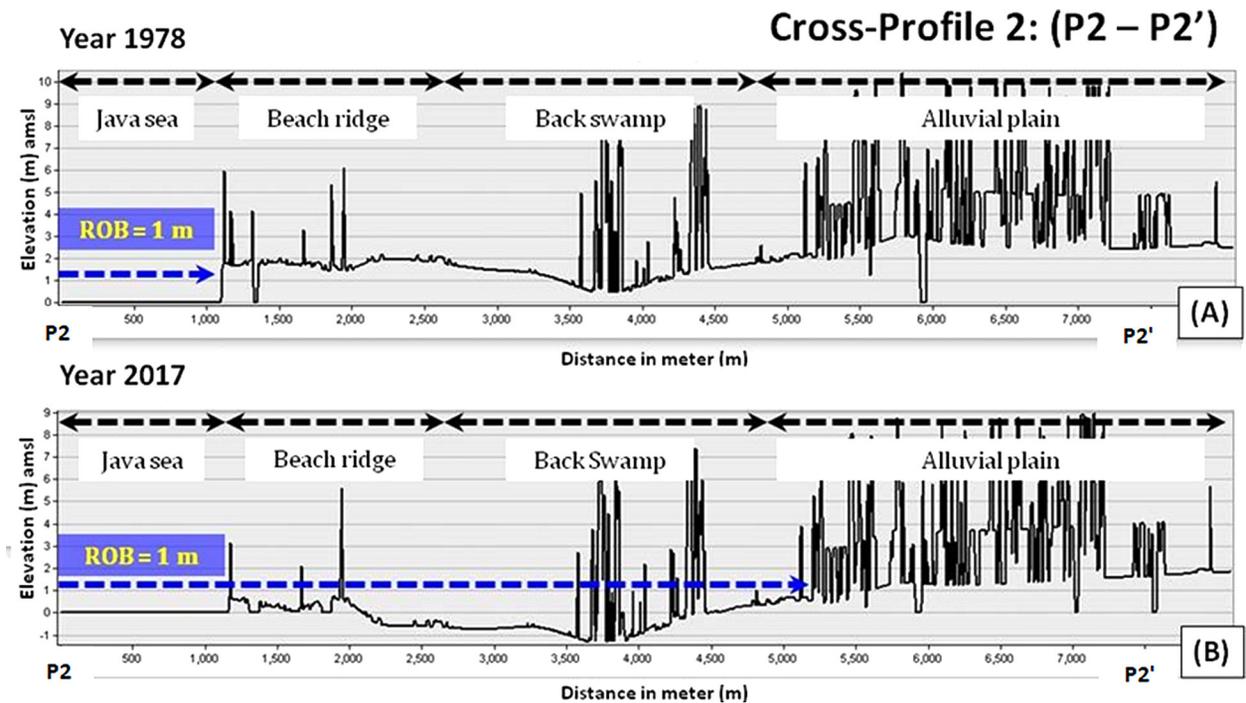
Fig. 9. Comparison results for morphological and topographic condition change from DEM modelling for 1978 and 2017 for cross-profile 2 (P2-P2') and their implications for vertical tidal flood distribution in coastal landform areas.

A. DEM cross-profile 2 in 1978; B. DEM cross-profile 2 in 2017.

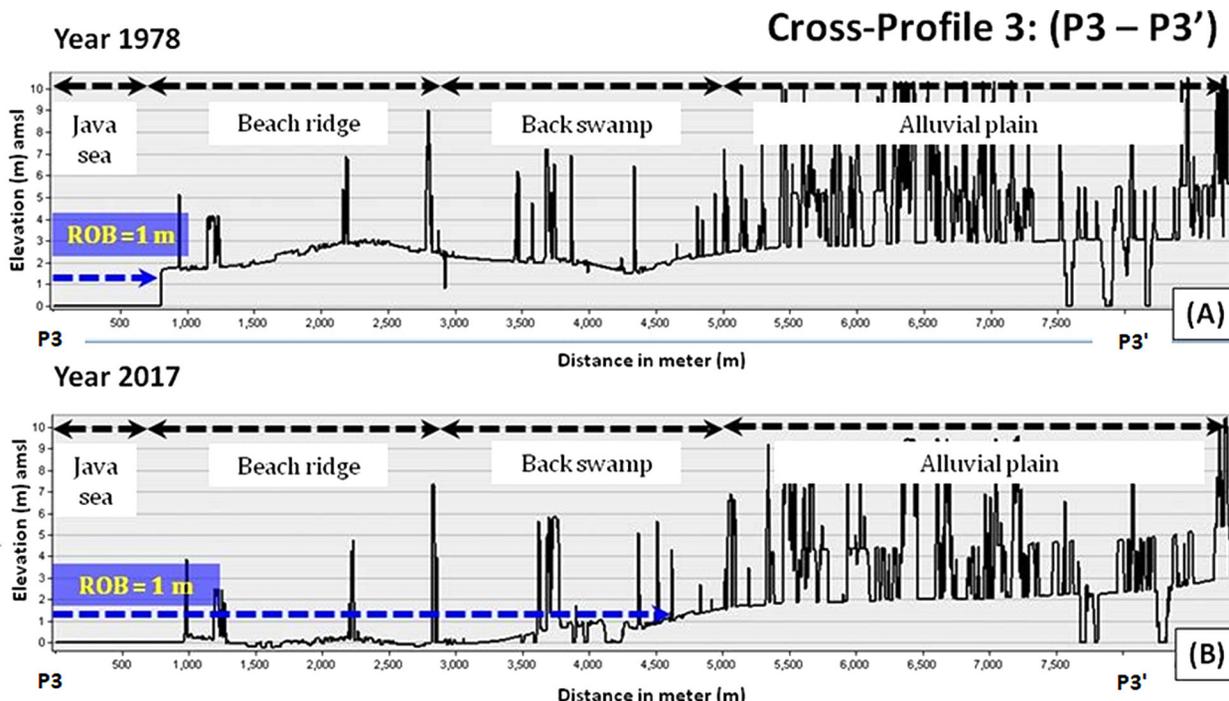
Fig. 10. Comparison results for morphological and topographic condition change from DEM modelling between 1978 and 2017 on cross-profile 3 (P3-P3') and their implications for vertical tidal flood distribution in coastal landform areas.

A. DEM cross-profile 3 in 1978; B. DEM cross-profile 3 in 2017.

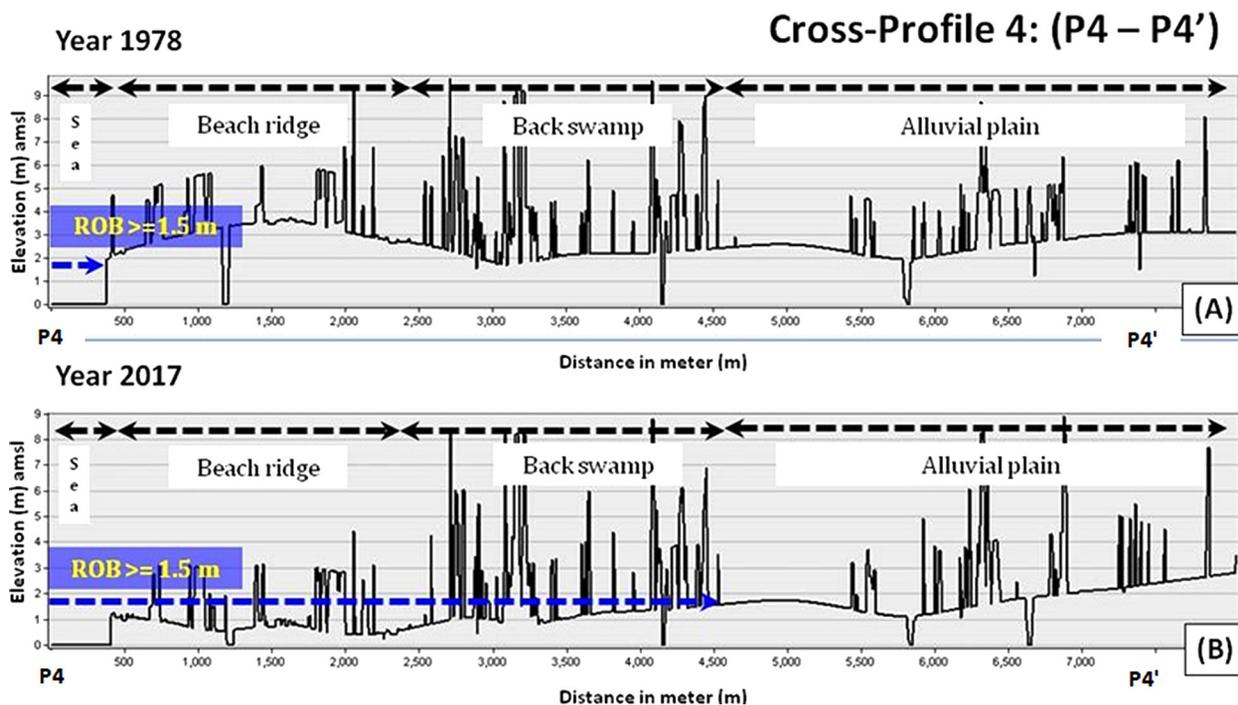
Fig. 11. Comparison results for morphological and topographic condition change from DEM modelling between 1978 and 2017 on cross-profile 4 (P4-P4') and their implications for vertical tidal flood distribution in coastal landform areas.

A. DEM cross-profile 4 in 1978; B. DEM cross-profile 4 in 2017.

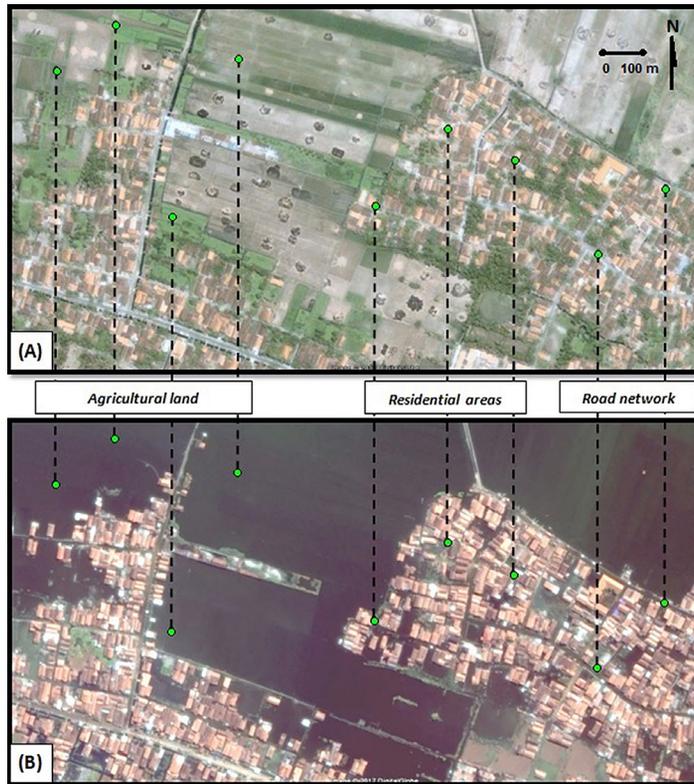
Fig. 12. Areas affected by flooding, such as agricultural land, residential areas and road networks in Jeruksari Village, Tirto District, Pekalongan Regency. (Source: Google Earth; CNES (the French space agency)). A. Environmental conditions pre-tidal flood, 22 October 2006; B. Flooded conditions during/post-tidal flood, 28 April 2017.

Figure 12 shows some of the locations affected by tidal flooding in the study area, such as agricultural land, residential areas and settlements, roads and others (location inset is as in (Fig 3). Locations up to about 2 km from the coastline and on the backswamp appear to be flooded by tidal waters, spatially presented based on the comparison of satellite image recordings on 22 October 2006 (pre-flood) and 28 April 2017 (during/post-flood). As shown in (Fig. 13) and (Table 4) it can be seen that under the same conditions there are about 99.54 ha of backswamp in 1978 and 396.90 ha of backswamp in 2017, with the average increase in area for 1978 to 2017 being 7.63 ha yr<sup>-1</sup>, the location of settlements potentially affected by tidal flooding as it is located on the coastal landform on the backswamp class.

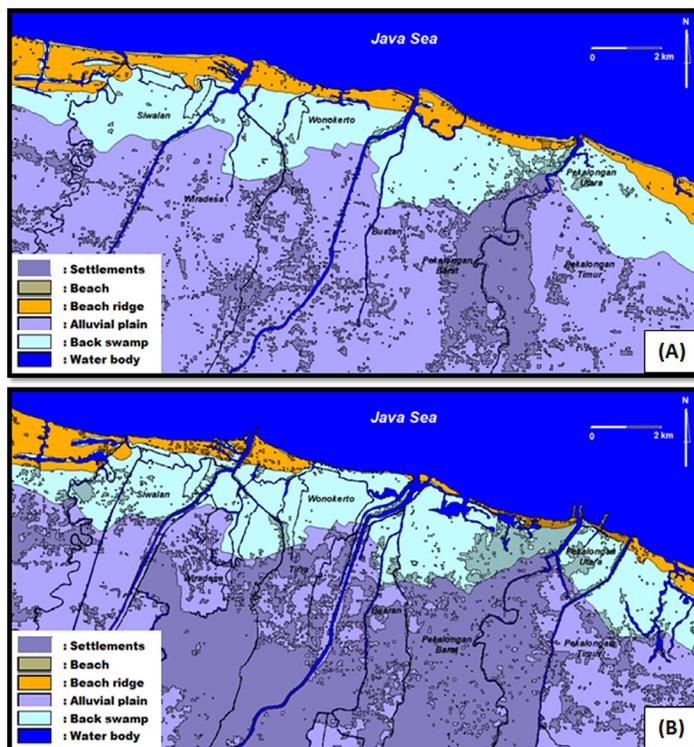
Fig. 13. Comparison of settlement distribution located on coastal landform between 1978 and 2017 in the study area. (A) Settlement on coastal landforms in 1978; (B) Settlement on coastal landforms in 2017.
