# CHANGES IN EROSION PROCESSES AND MORPHOLOGY OF STEP-POOL CHANNELS IN THE SKI RESORT WITH ARTIFICIAL SNOWMAKING, AN EXAMPLE FROM GUBAŁOWSKIE FOOTHILLS

PIĄTEK D., GOŁĄB A., WROŃSKA-WAŁACH D., 2025. Changes in erosion processes and morphology of step-pool channels in the ski resort with artificial snowmaking, an example from Gubałowskie foothills. *Quaestiones Geographicae* 44(1), Bogucki Wydawnictwo Naukowe, Poznań, pp. 151–165. 8 figs, 4 tables.

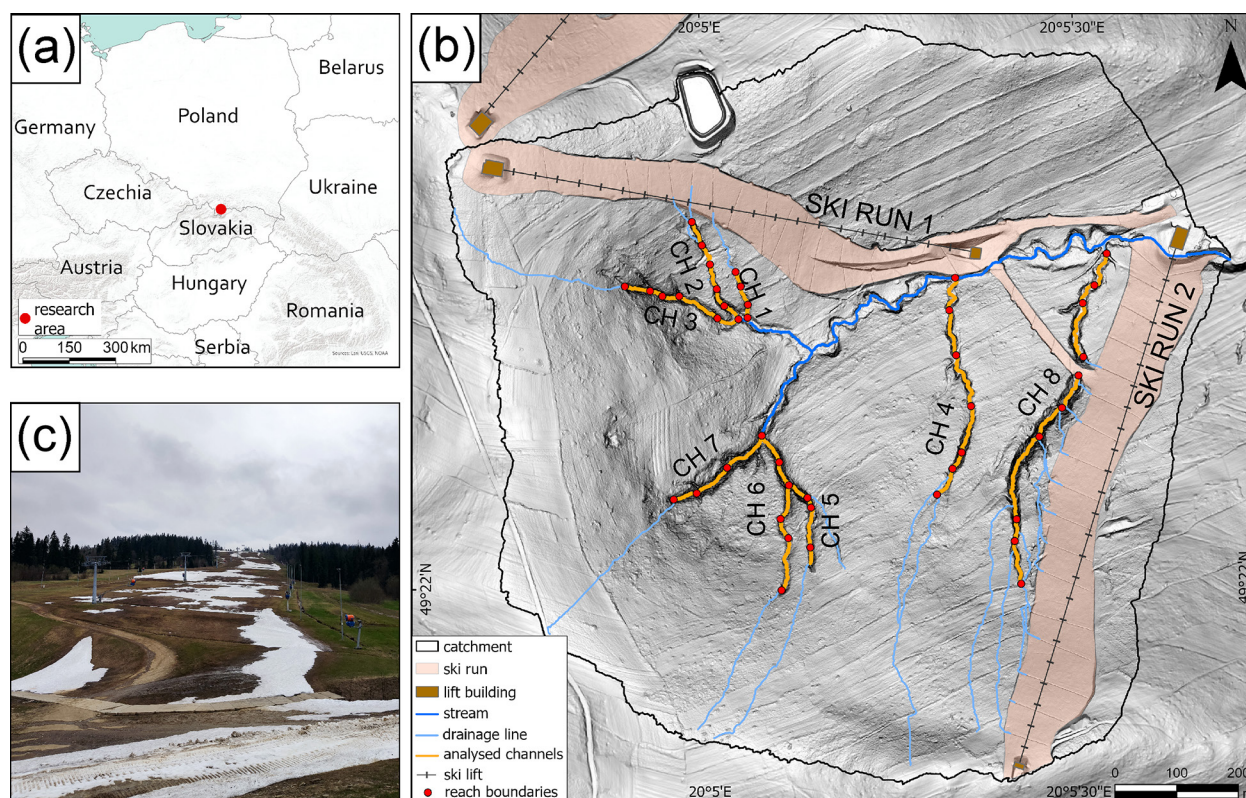
Fig. 1. Location of the study area: A – a regional overview, B – a hillshaded relief of the catchment with analysed channels. Channels are signed with CH and followed numbers. Important drainage lines and ski infrastructure are marked, and C – a photograph of the catchment with ski run 2 (photo: D. Piątek).

The study area consists of a small catchment of the Remiaszów stream (116 ha). It is located in the Gubałowskie Foothills in the Inner Carpathians (Fig. 1) and is part of one of the largest and most susceptible to erosion ski resorts in Poland: Kotelnica Białczańska (Krzesiwo 2014, Piątek et al. 2022). The area is formed of Podhale-type flysch consisting of sandstone shale layers and conglomerate horizons (Watycha 1976) and due to location in the area of neotectonic movements (Mastella et al. 1996), valleys in the studied area tend to aggradation and dominance of hillslope processes (Zuchiewicz 2010). Elevations range from 760 m to 950 m above sea level. The average hillslope gradient is  $14^\circ$ . Hillslopes have a straight and step-like profile due to the occurrence of agricultural terraces. The valley network of the Remiaszów stream catchment is 3.34 km long, and the channel density is  $2.88 \text{ km} \cdot \text{km}^{-2}$ . The valley depth reaches 9 m. The valley network consists of Strahler third-order streams and their tributaries: 8 first- and second-order channels, whose morphology and erosional activity were

our main points of interest. Three channels are located adjacent to ski runs 1 and 2 and drain water from ski runs (Fig. 1). The stream channels carry water only during snowmelt or after rainfalls.

The study area is 116 ha, and 17% of the area is covered by ski runs (19.7 ha) (Fig. 1). The ski run 1 was built in 2014 and is 8.76 ha; the ski run 2 was constructed in 2015 and is 10.74 ha. As a result of construction, 12% of the forest area in the catchment was removed. The construction of the ski runs was based on heavy earthworks, which significantly changed hillslopes. To level the hillslope surface by smoothing and lowering, about 43,000 m<sup>3</sup> of soil on ski run 1 and about 32,000 m<sup>3</sup> on ski run 2 were removed. In the different parts of the ski runs, the biggest changes occurred due to flattening of agricultural terraces, filling small gullies, and road construction, with height differences reaching up to 5 m (Fidelus-Orzechowska et al. 2018). The maximum elevation is 937 m for ski run 1 and 941 m for ski run 2. Denivelations differ from 165 m (the ski run 1) to 179 m (the ski run 2) (Fidelus-Orzechowska et al. 2018, Wrońska-Walach et al. 2019). Before the construction of the ski resort, hillslopes had been used agriculturally since the 17th century. A remnant of this is the presence of agricultural terraces. Ski runs are covered with drainage ditches that direct water flow from the ski runs into the channel network (Fig. 1). The ditches have a dense network and are routed diagonally to the ski run, which results in low-intensity linear erosion on the ski run's surface.

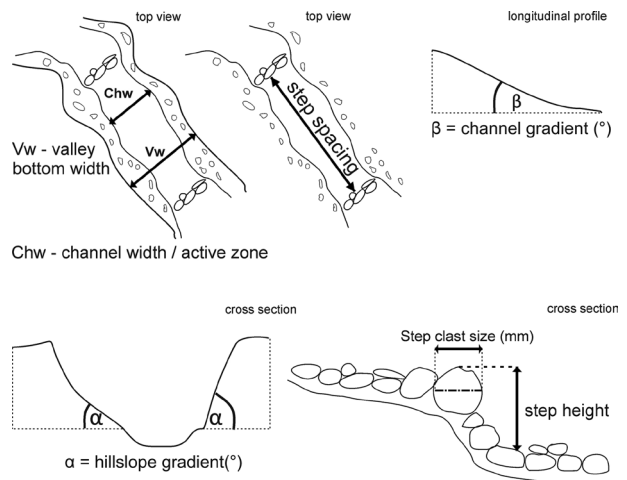
Fig. 2. Schematic diagram of selected measurements, black arrows and Greek letters show the way of measurement.

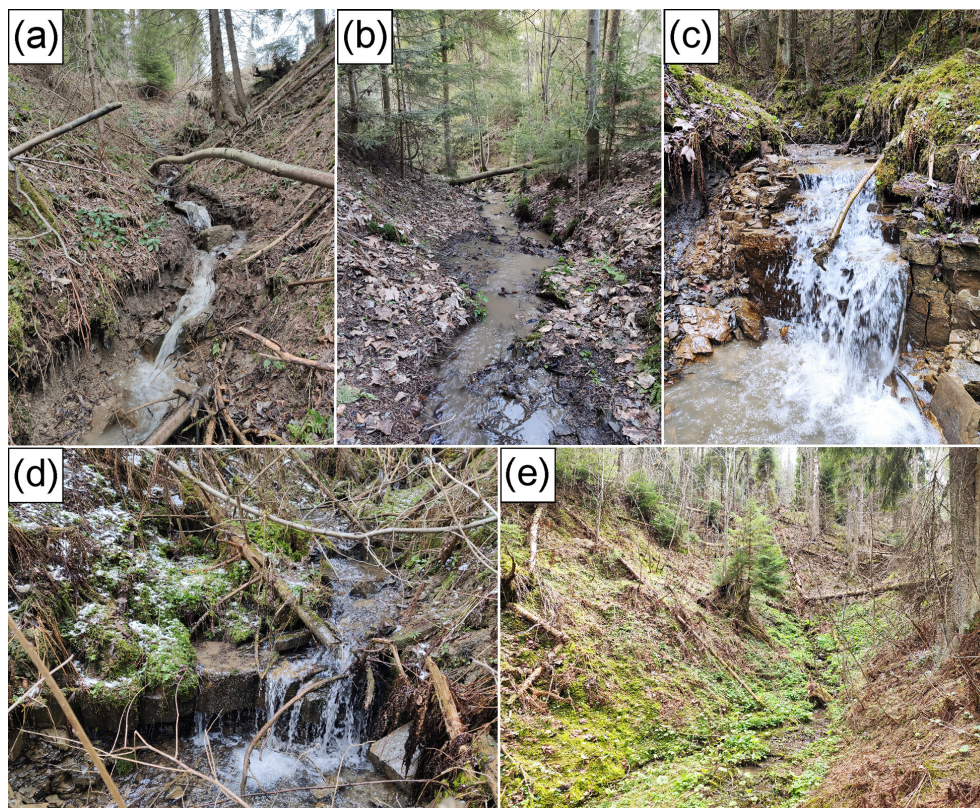
Fig. 3. Photographs of characteristic parts of analysed channels: A – a part of Channel 2 with traces of lateral and deep erosion, B – a part of Channel 4 with a relatively high gradient, C – a part of Channel 8 with a 0.6-m-high step below the rockfloor, D – a step with typical height for catchment, Channel 3, E – part of Channel 7, fulfilled with material from a small landslide visible in the left corner (photos: A. Gołąb and D. Piątek).

In the study catchment, the dominant type of channel morphology is step-pool. Channels unaffected by ski infrastructure in the upper parts are dominated by hillslope processes and have a cascade channel (Channel 3) or colluvial channel morphology (Channels 4, 5, and 7). In this group, small landslides are common, which transport material laterally, into the channels (Fig. 3E). Channels affected by ski infrastructure (1, 2, 8) (Table 1) are generally characterised by more traces of erosion, particularly related to deep and lateral erosion (Fig. 3A, C). Channel 8, located near ski run 2, in parts where it receives a lot of water, forms bedrock sections that are several dozen metres long (Fig. 3C).

channels, except Channel 8, where intense headward and deep erosion, probably due to water inflow from ski run 2, has resulted in significantly larger material sizes. A total of 718 steps were measured in all channels. The average step height remains relatively uniform and ranges from 0.31 m to 0.44 m (Fig. 3D). The greatest differences in step height occur in Channel 8, which receives water from the largest area of the ski run, while the smallest variations are found in Channels 3 and 6, which are unaffected by ski infrastructure. Step spacing also varies, with the widest spacing occurring in Channel 7 and the smallest step spacing is in Channel 1, directly adjacent to ski run 1. The number of steps per unit of channel length differs slightly between the analysed channels. The highest values are found in Channels 6 and 8, while the lowest occurs in Channel 4. The largest clasts form steps in Channel 8, with an average size of 730 mm. It is the effect of fragmenting the rock floors, formed as a result of intensive erosion, into large debris, which, transported along the channel, forms new steps (Fig. 3C).

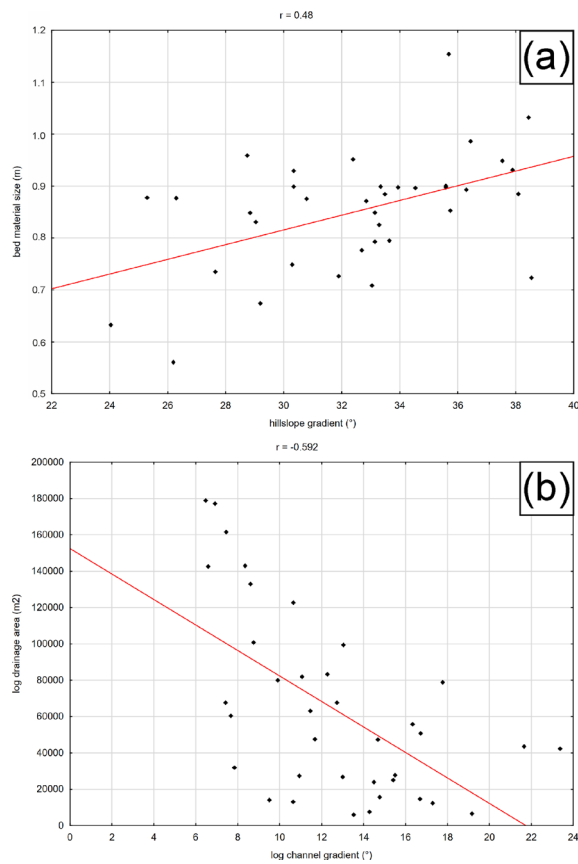
Fig. 4. Distinctive correlations in the group of all analysed channels (reach averaged data), A – hillslope gradient versus bed material size; B – channel gradient versus drainage area.

(Table 2). Most relationships are related to the hillslope gradient (5 relationships), the strongest correlation with bed material size (Fig. 4A). Hillslope gradient is also positively correlated with step clast size, channel width, and negatively correlated with valley bottom width. Channel gradient relationships are significant with drainage area (Fig. 4B) and with valley bottom width. The strongest correlation in this group is the relationship between bed material size and step clast size (Table 2).

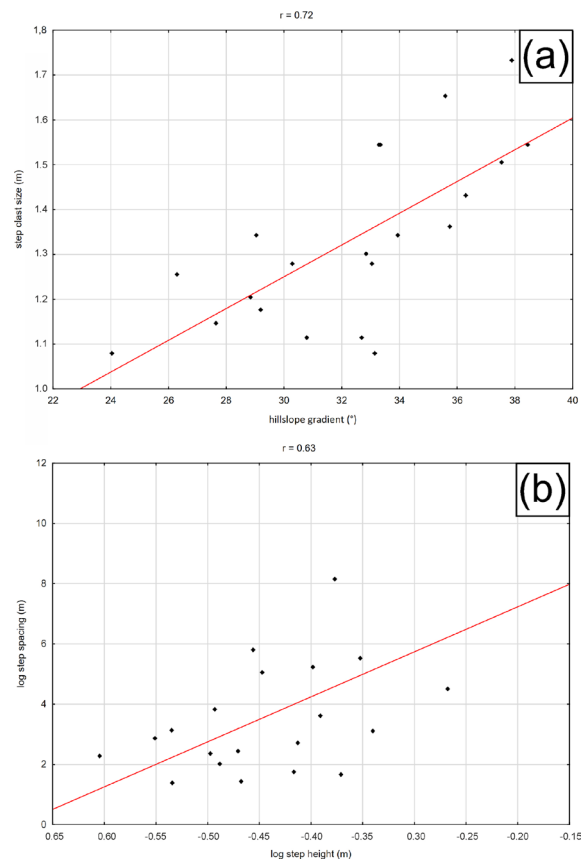
Fig. 5. Distinctive correlations in the group of channels without impact of ski runs (reach averaged data), A – hillslope gradient versus step clast size; B – step height versus step spacing.

In correlation with parameters from channels unaffected by ski runs, a total of 21% of relationships (14 relationships) are statistically significant (Table 3). The most correlations are with step clast size (four relationships, the strongest relation with hillslope gradient) (Fig. 5A). Significant correlations are between hillslope gradient and valley width and between the number of steps and the step spacing (Fig. 5B).

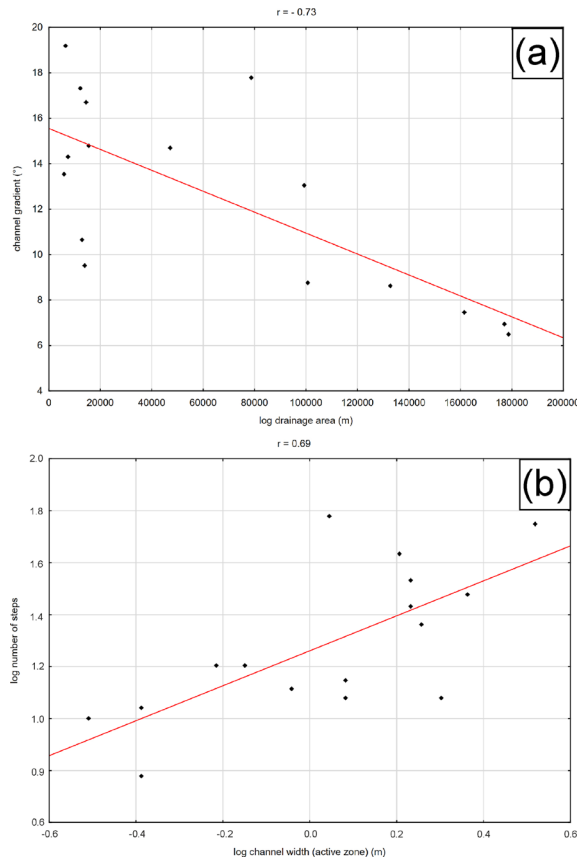
Fig. 6. Distinctive correlations in the group of channels affected by ski runs (reach averaged data), A – drainage area versus channel gradient; B – channel width versus number of steps.

channel gradient, the valley width (Table 4), and the channel width (Fig. 6B).

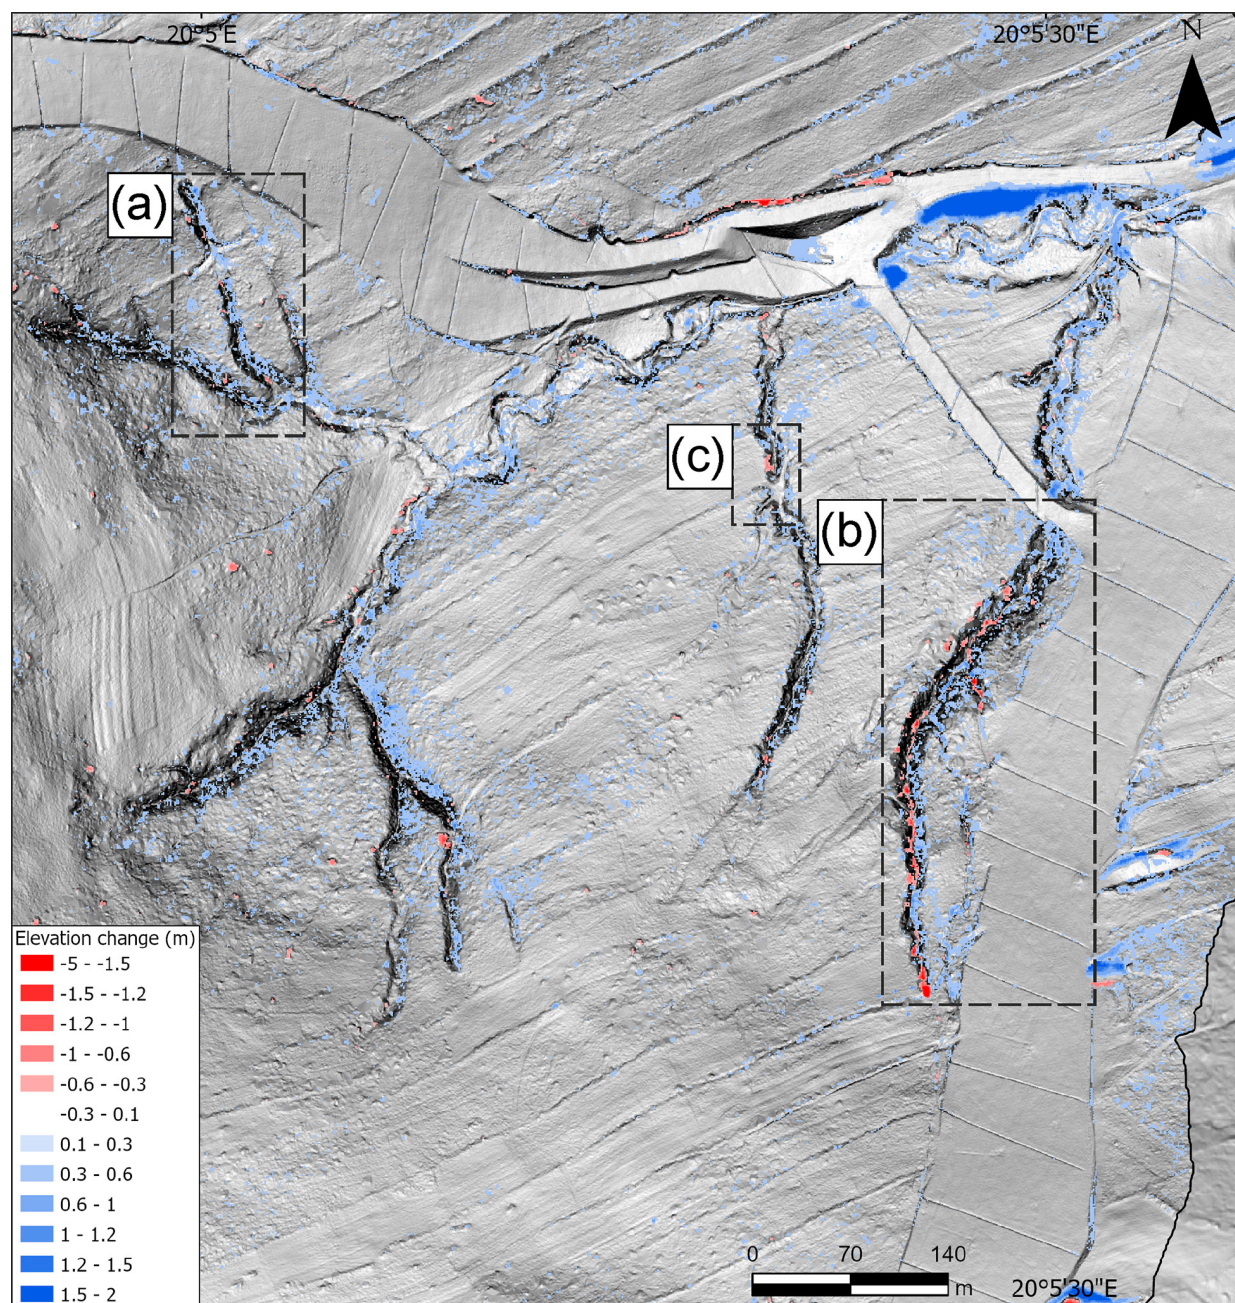
Fig. 7. Elevation changes in analysed channels in the period 2016–2023, in rectangle areas presented in Figure 8.

Analysing the changes in the ground level in all the studied channels, the results suggest a rise in all slopes of the valleys with a western aspect. This change has no confirmation in geomorphological processes or human impact and must be due to ALS errors and different angles during the ALS surveys. However, when analysing the bottoms of the channels, the changes are most clearly visible in Channel 8 (Fig. 7). Channels 1 and 2, classified as channels unaffected by ski infrastructure, during the study period have some sections marked by erosion of up to  $0.7 \pm 0.331$  m along a maximum length of 6 m. (Fig. 8A) This is backward erosion and erosion associated with the formation of new small colluvial channels as tributaries to Channels 1 and 2 (Fig. 8A). Due to outflow from ski run 2, in Channel 8, we can observe significant lowering in the channel bed (Fig. 8B). The maximum value of lowering is observed in the upper part of the channel and exceeds 2.6 m. It is a part of the channel where three drainage ditches route water. This also indicates

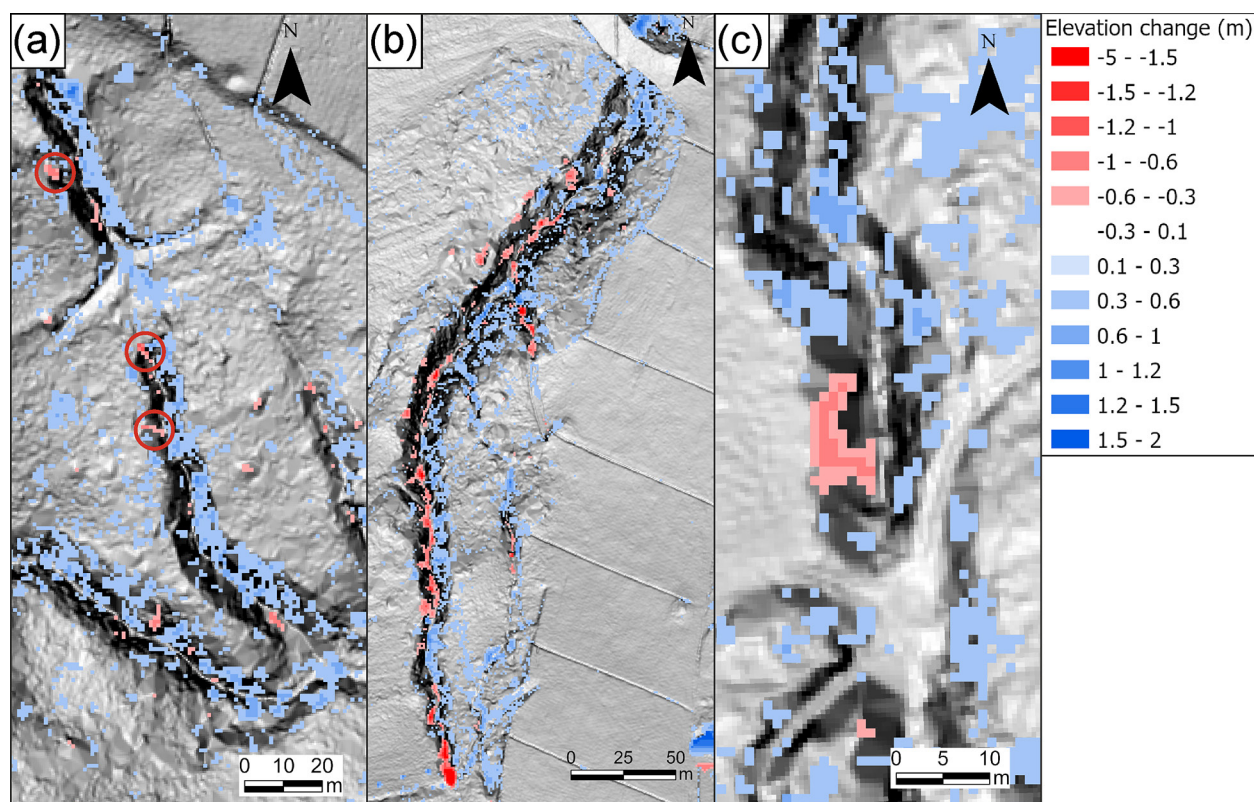
Fig. 8. Close up on areas with elevation changes marked with rectangles on Figure 7; A – close up on Channel 2, in red rings marked results of headward erosion; B – close up on Channel 8 with zones with erosion and deposition; and C – close up on a small landslide on hillslopes of Channel 4.

an intense head cut of the valley. Erosion exceeding an average of  $1 \pm 0.331$  m and reaching a maximum of  $2.6 \pm 0.331$  m occurs over a length of 41 m (Fig. 8B). After a short section of the channel with no change, there is a 240 m long section with an average lowering of the ground surface of  $0.5 \pm 0.331$  m and a maximum of  $1.7 \pm 0.331$  m (Fig. 8B). Below the new gullies with intensive erosion, Channel 8 is characterised by alternating deposition (average  $0.6 \pm 0.331$  m and maximum  $1.2 \pm 0.331$  m) and erosion (average  $0.4 \pm 0.331$  m and maximum  $1.5 \pm 0.331$  m) (Fig. 8B). The section

below the ski run link is characterised by a dominance of deposition between  $0.5 \pm 0.331$  m and  $1 \pm 0.331$  m. Channel 8 enters the main stream channel with an intensively overbuilt alluvial fan with an area of 218 m<sup>2</sup>. An average overbuild is  $0.6 \pm 0.331$  m, and a maximum is  $1.3 \pm 0.331$  m (Fig. 8B). In the channels described as channels unaffected by ski infrastructure, there is a limited change. Erosion is most common on the hillslopes and is associated with the formation of small landslides (up to 1 m of lowering) (Fig. 8C), which we often observed during fieldwork.
