FINDINGS ABOUT THE EARLY MEDIEVAL FORTIFICATION OF THE MIKULČICE – VALY ACROPOLIS

Abstract: The author evaluates the available information about the fortifications of the Mikulčice acropolis, the main area of the Early Medieval agglomeration. He gives a new perspective on the structure and dating of the fortification based on analyzing the documentation of all conducted excavations. Great Moravian rampart is composed of a stone face wall, clay-wood core strengthened by grates and a stone substructure ringed by stake palisades, in front of, and in some places partially under, the face wall. The substructure's role was most likely to bear the face wall's weight and to strengthen the artificial slope under it against water erosion by the nearby river. The defensive wall was built in a relatively short time as a singular structure, probably in the last third of the 9th century.

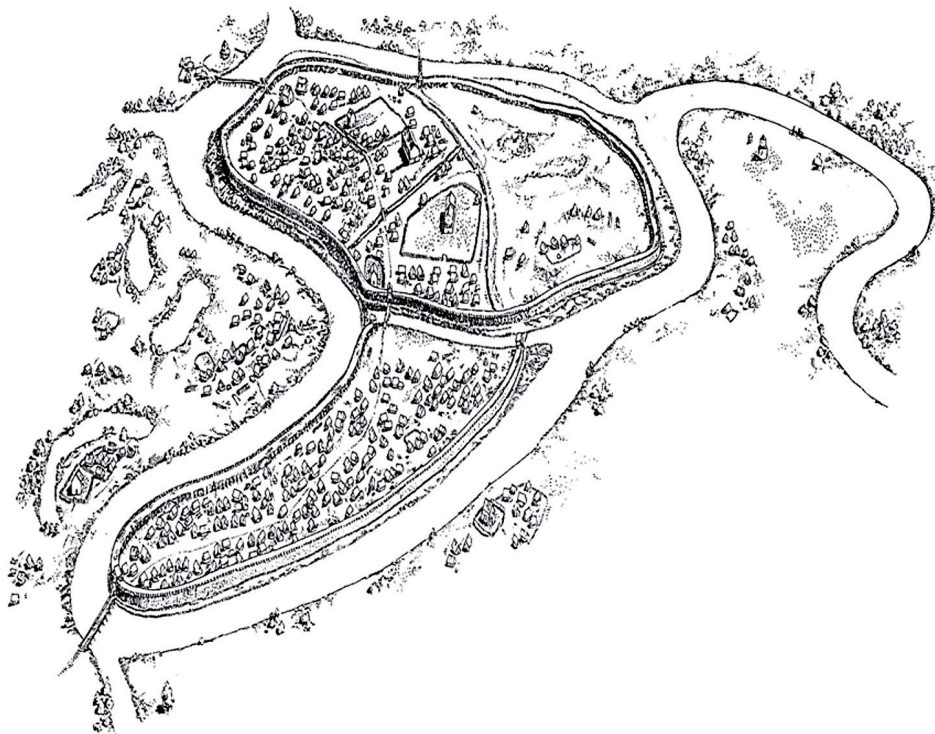
Fig. 2. Mikulčice-Valy. An ideal full reconstruction of the Mikulčice fort's fortified quarters at the pinnacle of Great Moravia (drawn by R. Skopal)

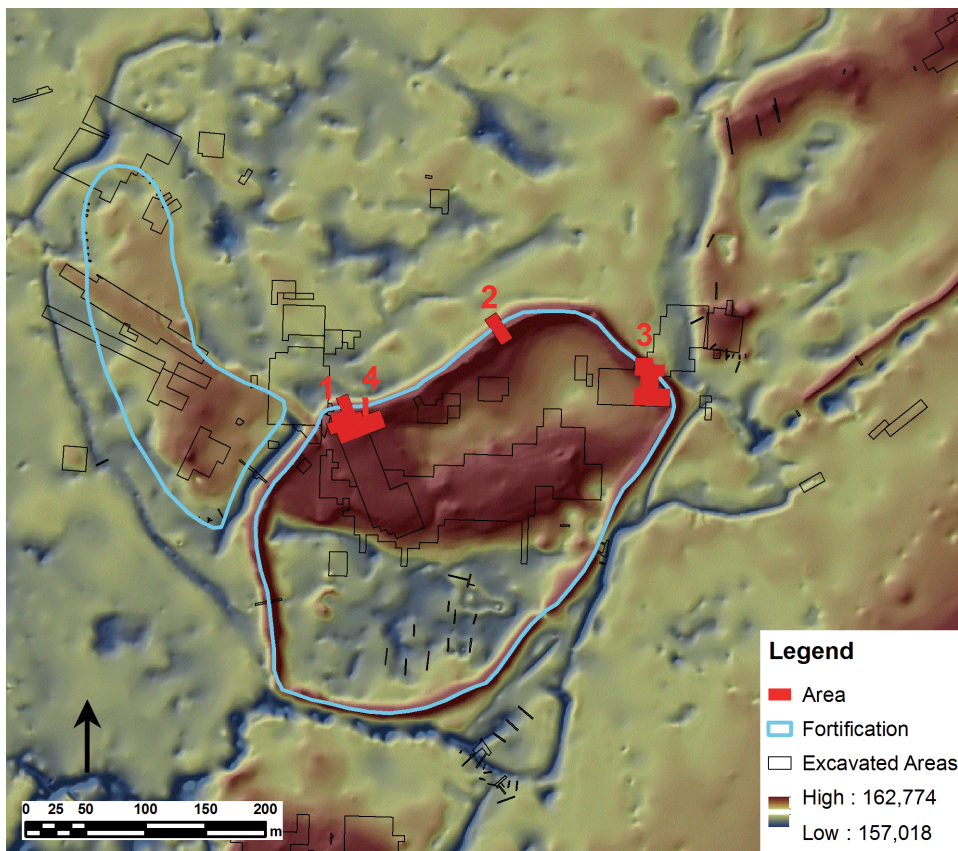
Fig. 3. Mikulčice-Valy. Previous excavations of the Mikulčice acropolis fortifications: 1 – NW section, area Church II. 1955-1959; 2 – N section, area R 1963-64; 3 – NE section–NE gateway, area Z 1979-1981; 4 – NW section areas R 2012 I, II overlapping the 1950s excavation

In the first case, at the outset of archaeological digs at the Mikulčice fortified settlement (part of the investigated area Church II. 1955-1959 – see Fig. 3.1), part of the core structure was mistakenly interpreted as a series of dugouts (relying on

In the second excavation (area R 1963-1964, Fig. 3.2), the middle of the northern section of the fortification was chosen, which unfortunately turned out to be considerably disturbed by secondary modern activities (furnaces, see Mazuch 2012a). Besides that, the second half of the probe was not fully dug and the explored stretch thus included only a width of 5 m, i.e. one archeological square.

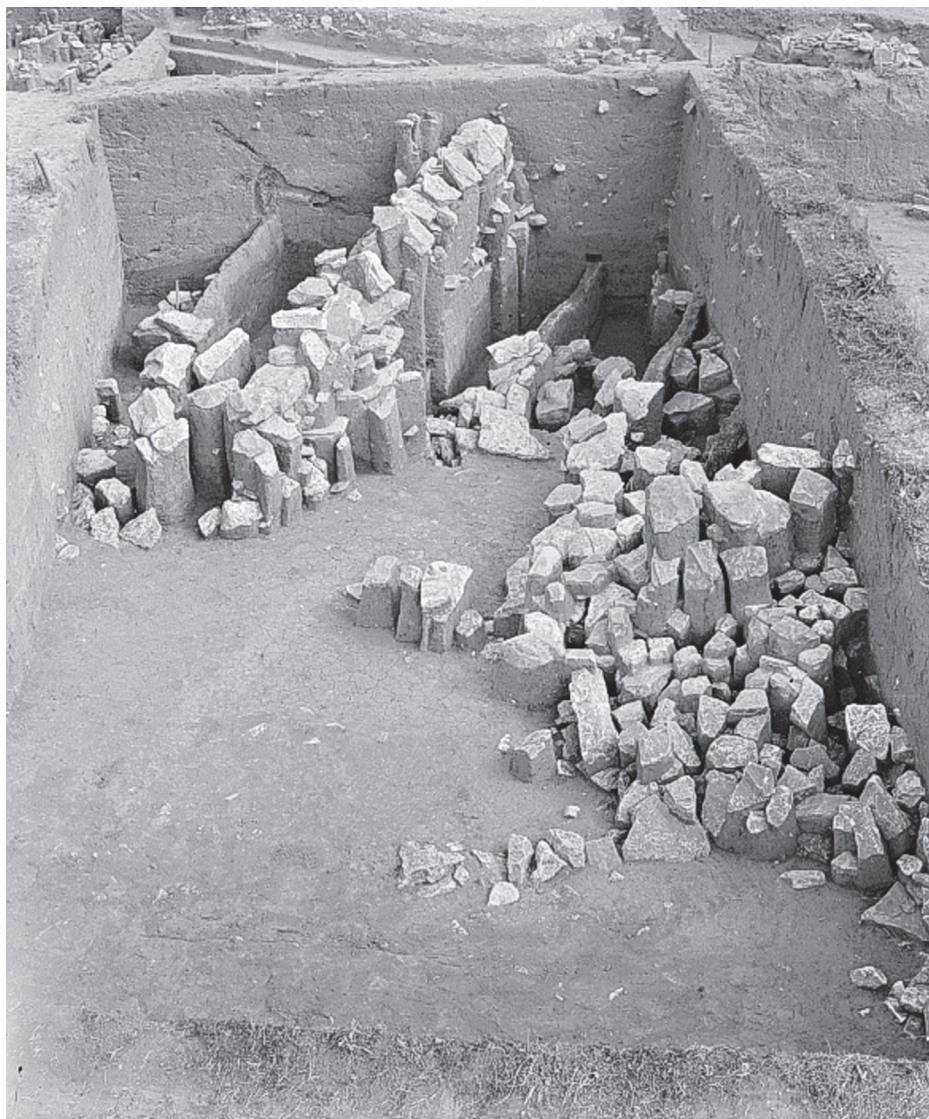
Fig. 4. Mikulčice-Valy, area Church II. 1955-1959, from the NNW. “Stone chamber wall”. Intrusion of face wall stones into the rampart core (findings at the interface of the D1 and D2 squares, before terrain removal to the level of the destroyed face wall remains)

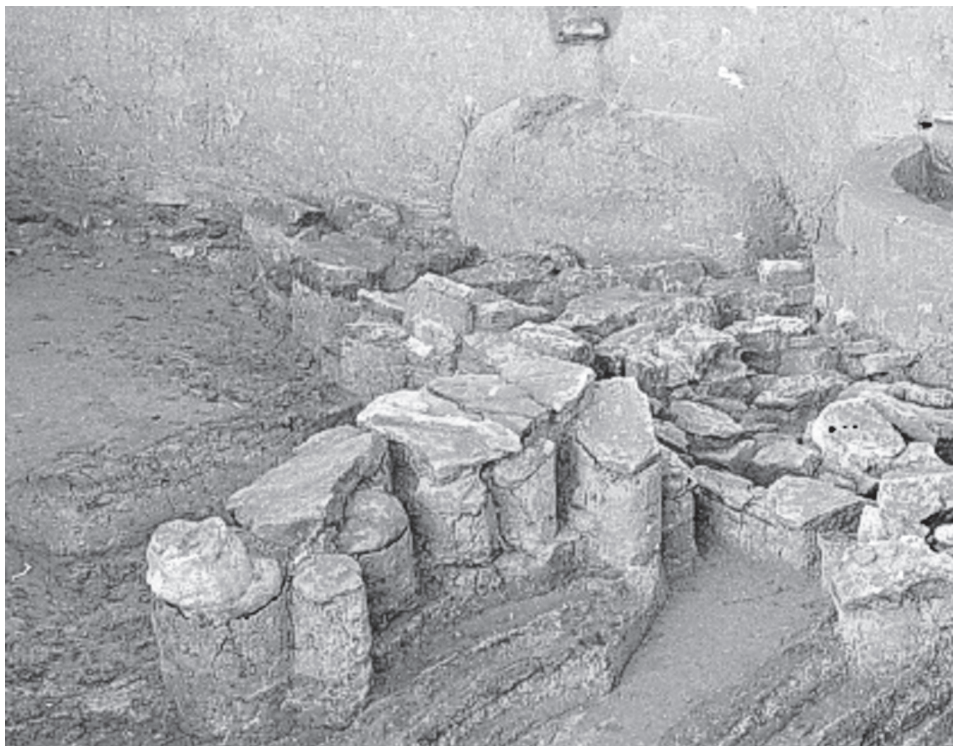
Fig. 5. Mikulčice-Valy, area Church II. 1955-1959, from the SE. Uncovered base grate in F2 including the stones intruding into the rampart core. Remains of two Modern era furnaces present in the profile. The figure captures the section (after wood removal) uncovered during the rescue excavation R 2012 I. The profile on the right is the cross-section between the R 2012 I and II research areas; this photo fills in the blank on the lower left edge of Fig. 24, the furnace on the left is the same one pictured in Fig. 18 and 20

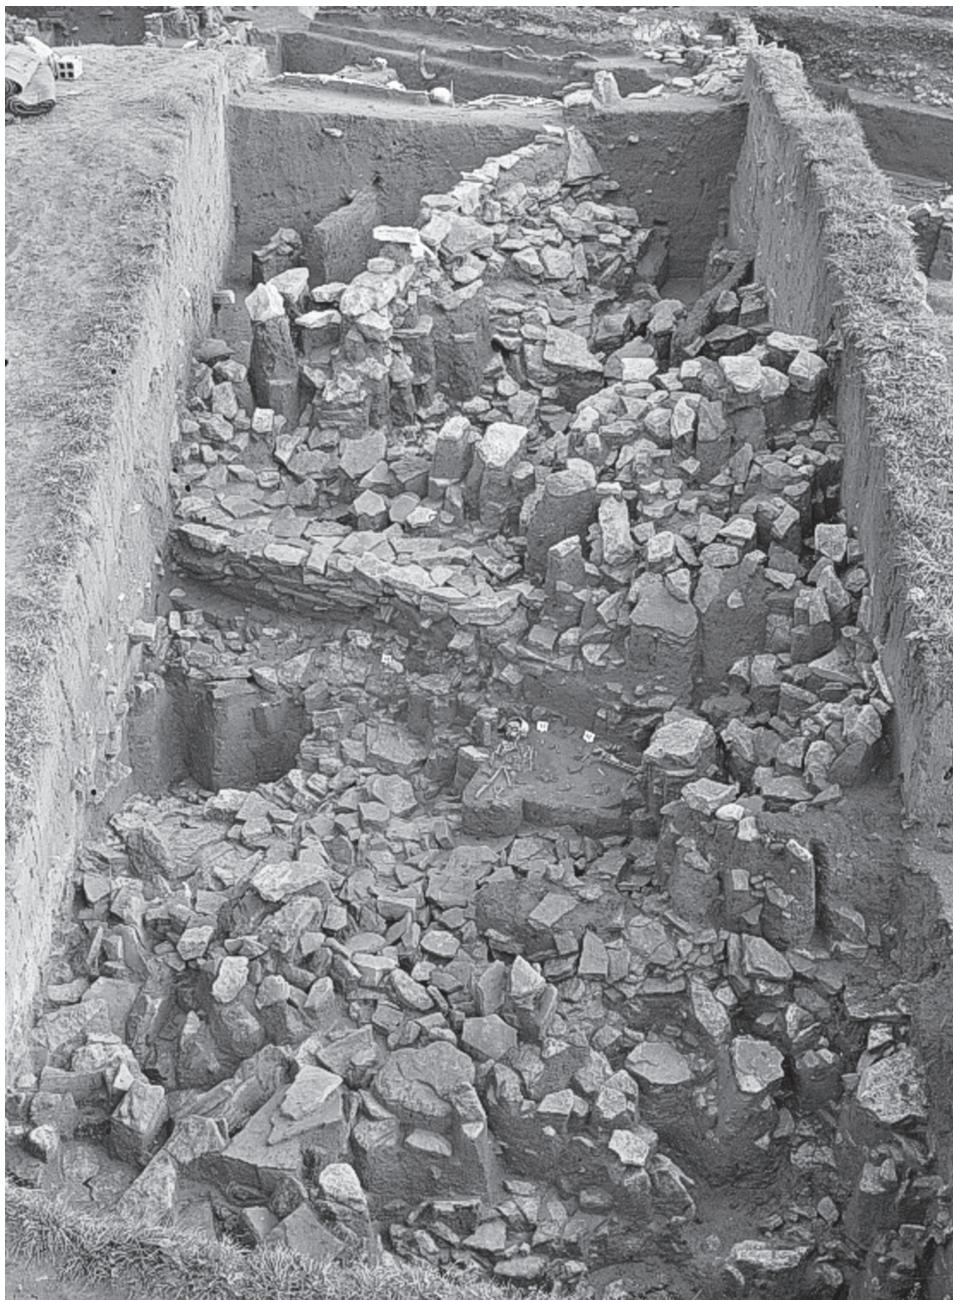
Fig. 6. Mikulčice-Valy, area Church II. 1955-59, from the NNW. The findings from squares D1-D0. The mid-left shows the preserved original face wall before it was “repaired”, with skeletal remains No. 40-42 in front of it, the top of the stone substructure is in the foreground

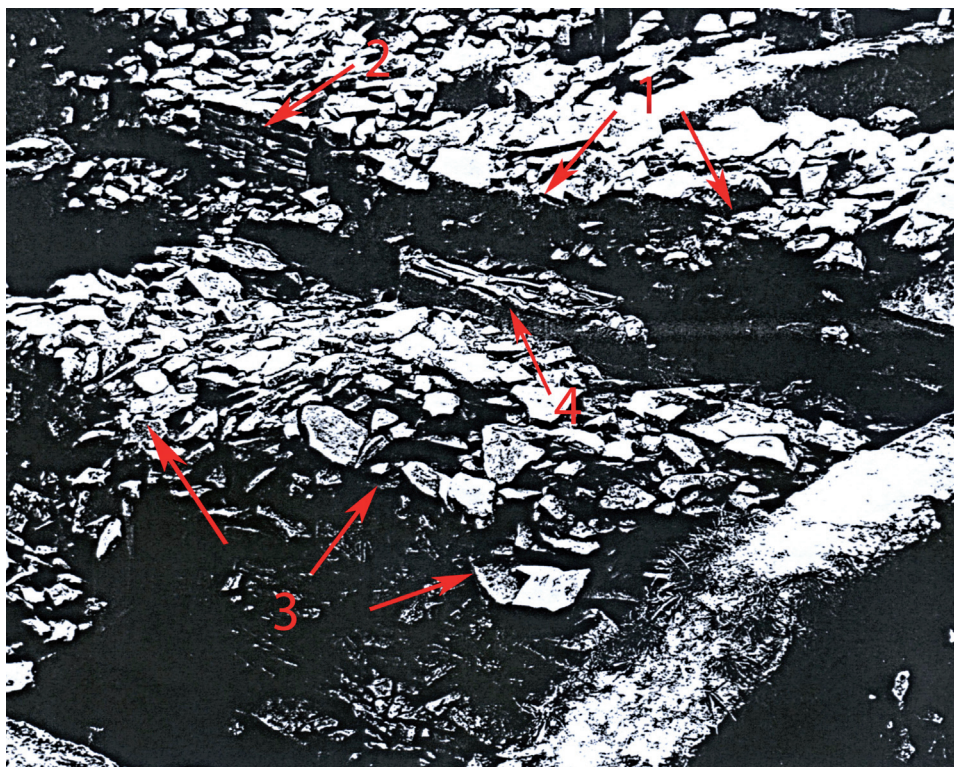
Fig. 7. Mikulčice-Valy, area Church II. 1955-1959, from the NW. Detail of the findings in D0. The original photo was unfortunately not preserved, but the low-quality paper copy presented still has great informative value.

Legend: 1 – face wall remains; 2 – “repaired” face wall, put forward as the most preserved portion of the Mikulčice fortification (cf. Fig. 6); 3 – the front edge of stone substructure; 4 – grave No. 262 (individual found on the top of the substructure directly in front of the face wall)

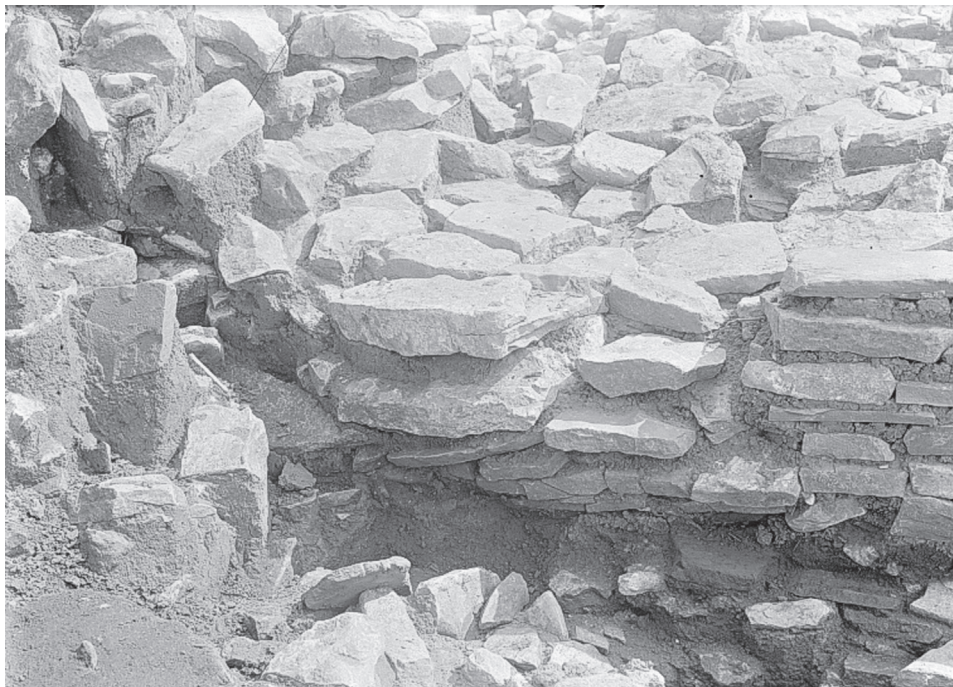
Fig. 8. Mikulčice-Valy, area Church II. 1955-1959. Detail of the face wall. Original on the left and very noticeable fresh masonry put up by a researcher during the excavation (see Fig. 6, 7)

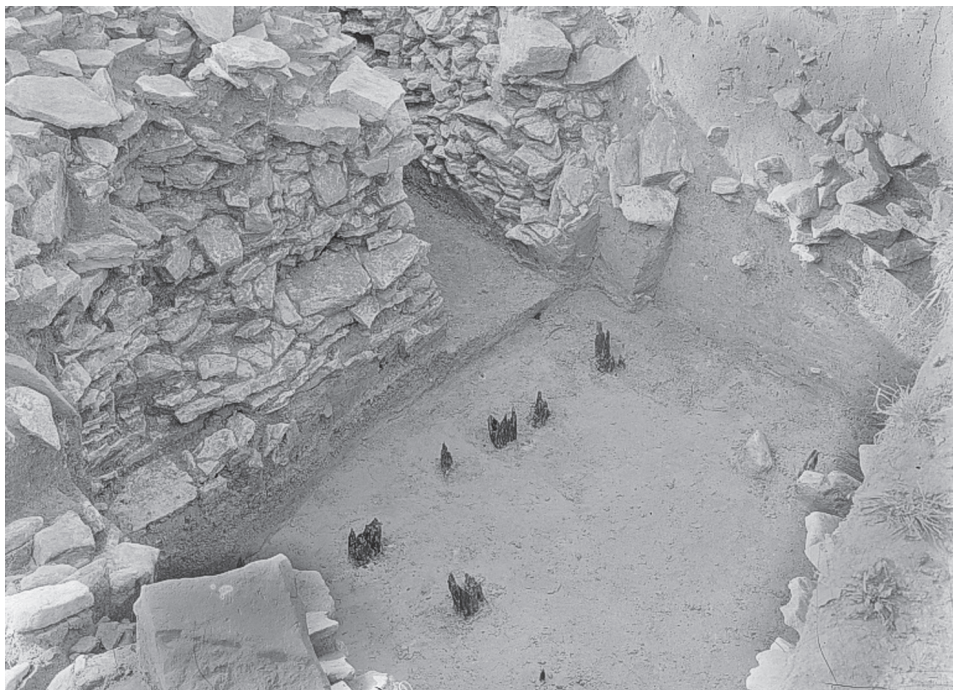
Fig. 9. Mikulčice-Valy, area Church II. 1955-1959, from the N. Detail of the stone substructure face and palisades – originals of a few stake spikes preserved

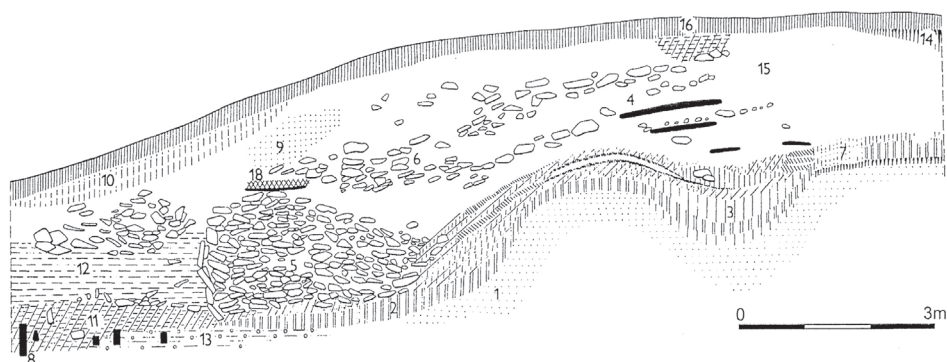
Fig. 10. Mikulčice-Valy, area Church II. 1955-1959. Fortification cross-section in squares C1-C0 (by J. P o u l í k 1957)

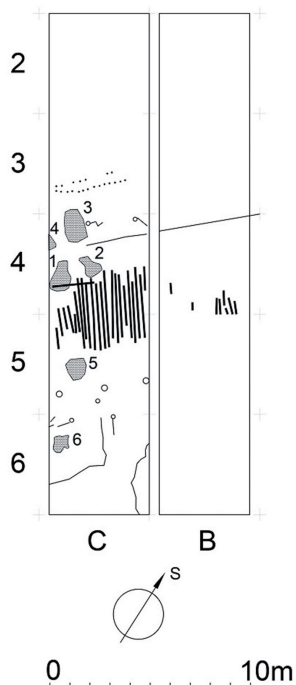
Fig. 11. Mikulčice-Valy, area R 1963-1964. Full generalized excavation plan. The sloping line marks the course of the face wall (above it are the holes left by the palisade), the thicker lines show the base grate and the numbers are modern furnaces, which significantly disrupted the situation regarding the Early medieval findings. Evenly spaced holes, left by wooden stakes supporting the back of the fortification, are noticeable between furnaces 5 and 6

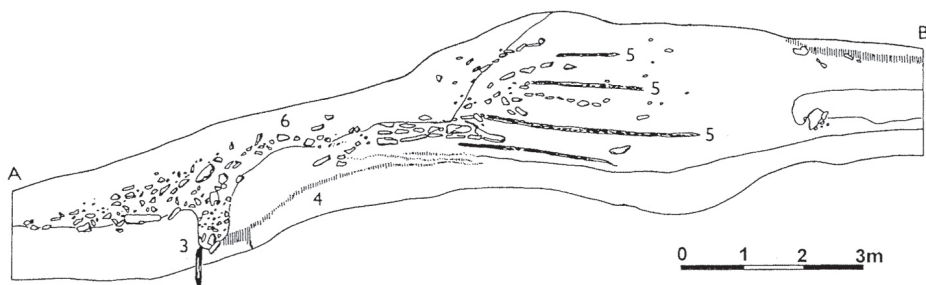
Fig. 12. Mikulčice-Valy, area R 1963-1964. Fortification cross-section between bands B and C (by R. Procházka 2009)

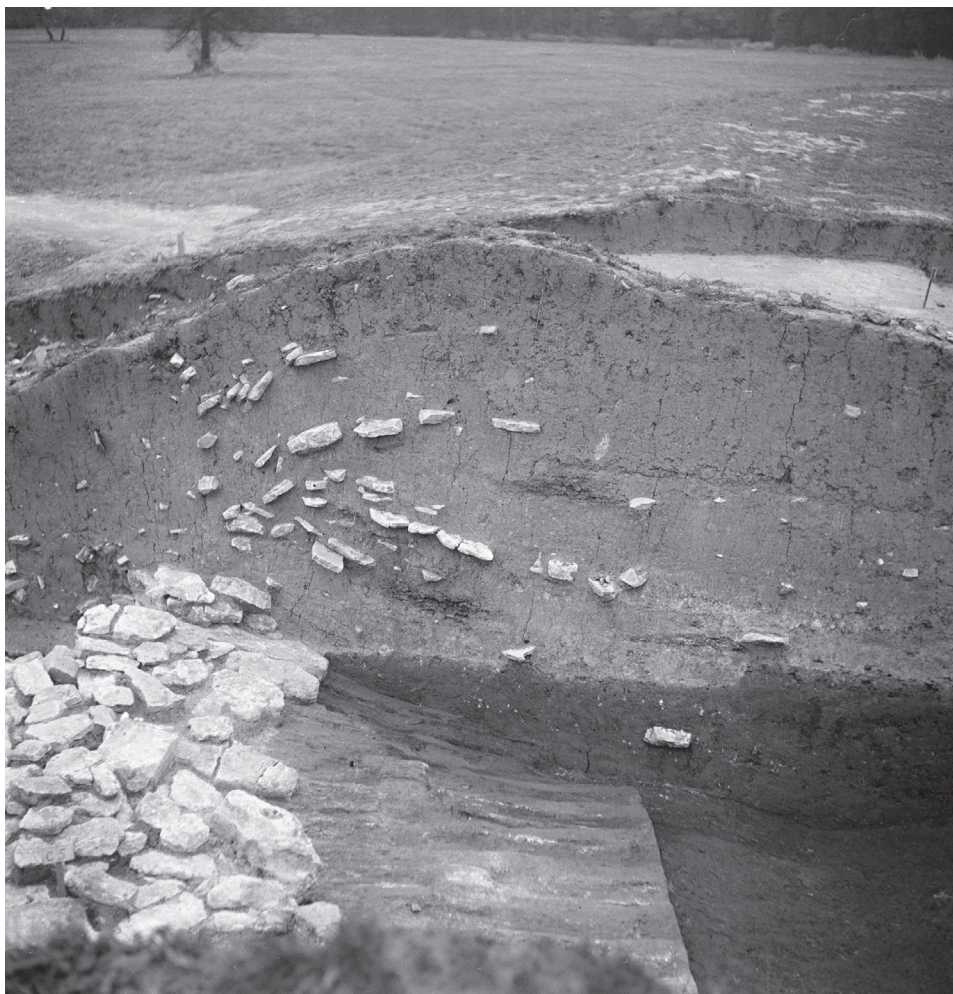
Fig. 13. Mikulčice-Valy, area R 1963-1964. View of the NE cross-section of the C band with the face wall and base grate uncovered (situation identical to Fig. 12)

The lowest 4th layer lies right under the front wall face and constitutes its base grate (see Fig. 13). It is placed about 40-50 cm lower than the 3rd layer, at a depth of about 1.95 to 2.35 m from the highest point of the rampart. It begins at about 90 cm behind the wall face (thus not directly under it, as might be expected, see above) and ends 4 m behind it. The planks are therefore about 3.1 m long. The

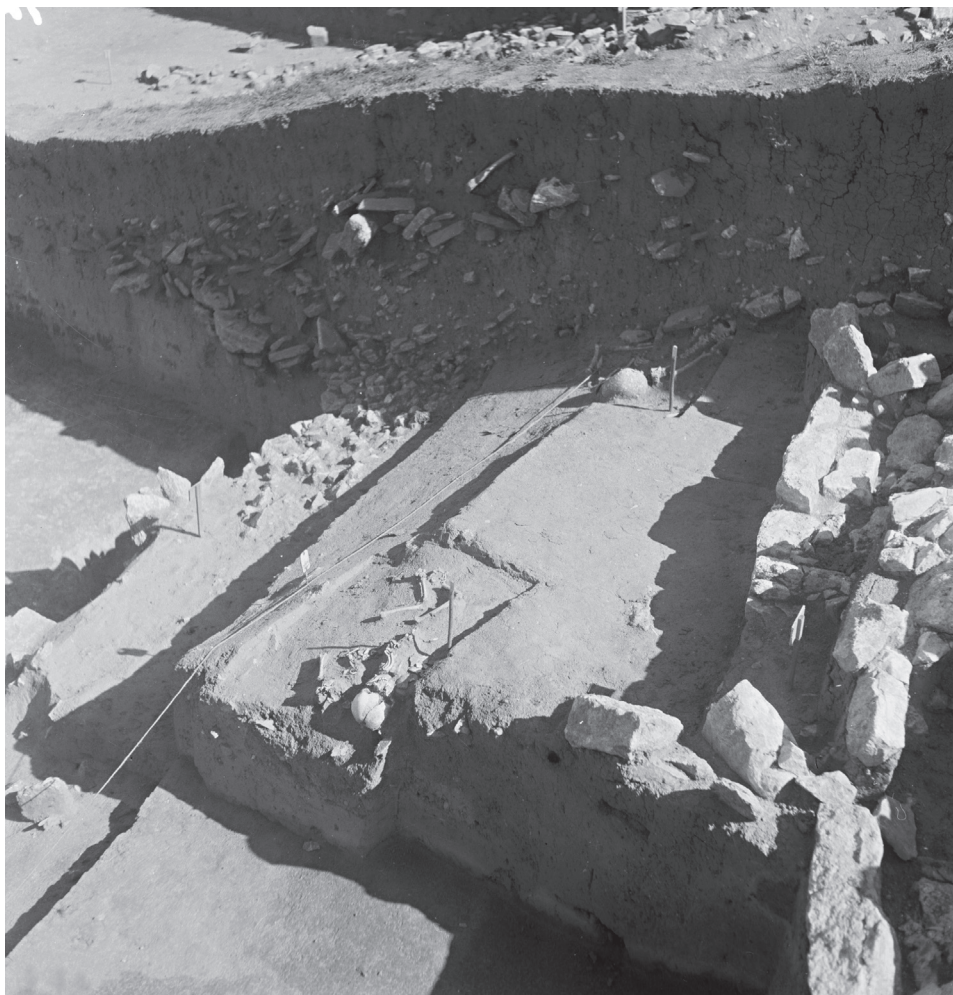
Fig. 14. Mikulčice-Valy, area R 1963-1964. View of the NE cross-section of the C band, in front of the face wall. Easily visible face wall on the right, almost removed stone substructure on the lower-left (smaller stones easily visible), stones from the destroyed face wall above it. Skeletal remains No. 790 and 791 in front of the face wall

As in the previous dig near church II., there were human skeletons found immediately under the destroyed remains of the front wall, in the area between the foot of the wall and the top of stone substructure. The human remains were unceremoniously dumped here (graves No. 790 and 791 – one is not even prone and the other is on its belly, see Fig. 14).

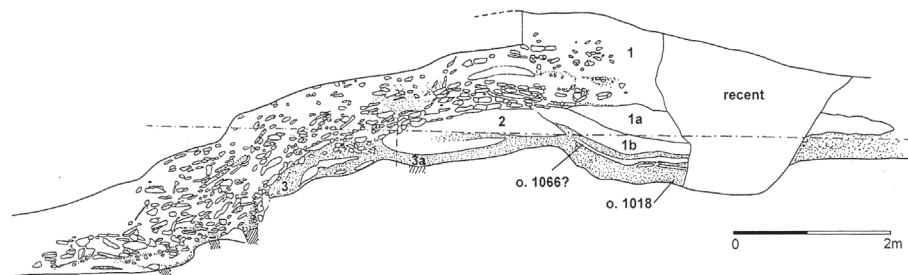
Fig. 15. Mikulčice-Valy, area Z 1977-1981. The only fortification cross-section in this area (by B. K a v á n o v á 2003); excavation labeled “recent” is in fact an archeological probe, dug before this cross-section was taken (it is only spatially located, with no other documentation!), this section of the rampart core was destroyed by the archeological “excavation”, leaving no documentation

nature, because of the inadequate terrain removal, or at least its nonexistent documentation. There were no transverse cross-sections of the fortification in the evaluated section. The only useful cross-section (Fig. 15, see above; it consists of a number of cuts, which don't connect directly and which are not put together precisely enough in the published documentation) is the SE edge of the area in squares 44/-18, 45/-18 (partially evaluated, undocumented), 45/-19, 46/-19 and 46/-20 (the last two also undocumented).

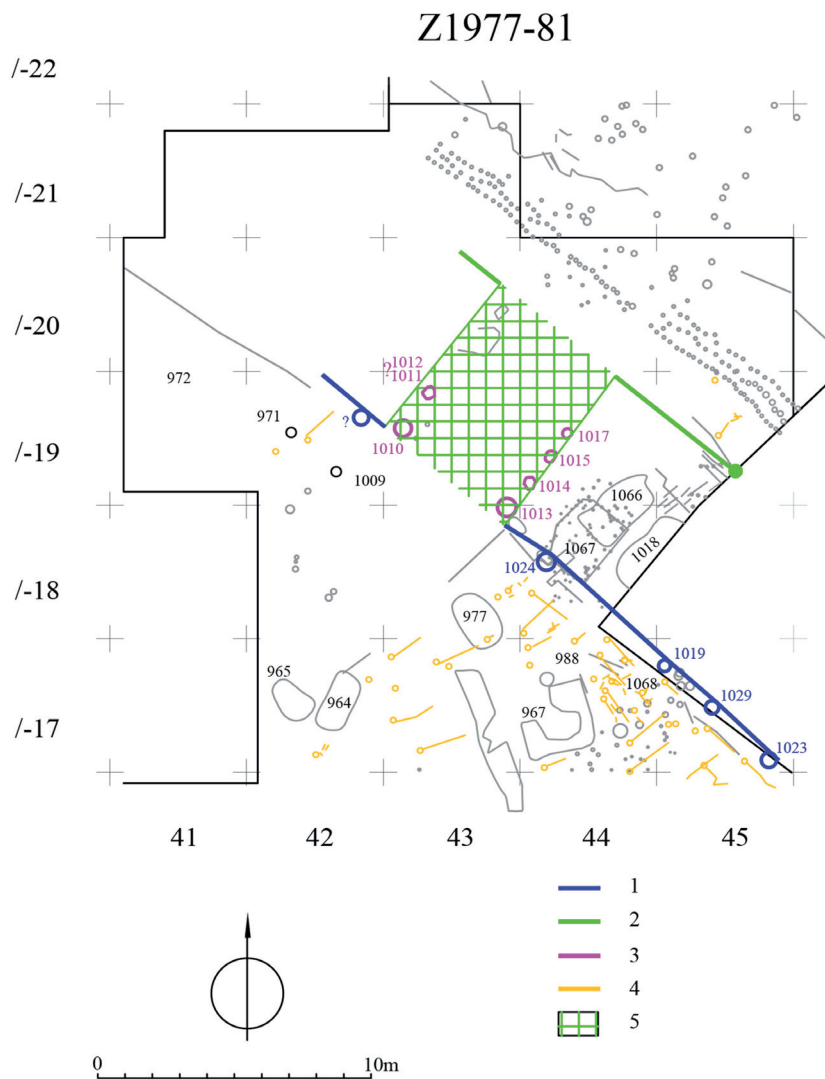
Fig. 16. Mikulčice-Valy, area Z 1977-1981. Full plan of the area including a reconstructed course of the fortification and gateway (by Mazuch 2012c). Legend: 1 – course of the rear of the rampart with supporting stakes; 2 – reconstructed course of the face wall and stones of the gateway; 3 – stakes from the structure of the wooden gate itself; 4 – graves; 5 – area of the gateway through the wall

In the space of the bridge leading up to the gate, the 3-layers of stakes were reduced to just one (the innermost one, see Fig. 16). It is hard to determine if this finding truly reflects the reality or if it is caused by an inability to recognize/find the other stake-holes during the excavation. The presence of a line of stakes points to the fact that the stakes and even the stone substructure could have been built before the bridge itself (however, these two actions should not be taken as chronologically significantly different, they could have been built subsequently) and that the substructure didn’t reach the height of the bridge deck. From a practical standpoint, the innermost palisade (assuming a slope) would be more of an obstacle for the bridge than the other lower-lying ones. Additional stakes could have been used to strengthen the bank in indeterminable time intervals, as required by the river bank erosion (cf. P r o c h á z k a 2009, p. 167), although there is no evidence to support this. From personal experience during excavation R 2012, it is very hard to recognize the imprints of stake points at or below the water level.

a part of the fortification, I will mention the important findings here. The gate itself was flanked with stone on both sides. The width of this gap from wall to wall, which contained the wooden gate door, was about 5.6 to 5.7 m. If the excavation found all the stake holes belonging to the gate tower, then the gate was thinner than the thickness of the rampart. Its outer edge was then inset about 2.6 m behind the face wall of the fortification (the wooden bridge probably started right at the line of the wall face), while its inner edge lined up with the back of the rampart (see Fig. 16). The gate's passage would then be about 4.5 m wide and 4 to 4.1 m deep.

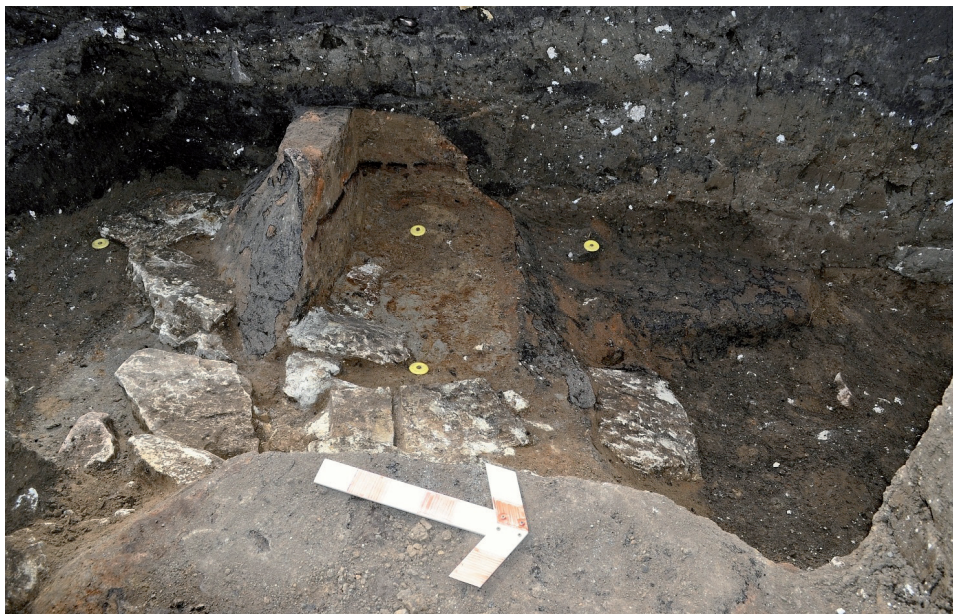
Fig. 18. Mikulčice-Valy, area R 2012 I, II. Detail of a modern clay furnace, found on the destroyed remains of the face wall (W profile of probe 91); the furnace was already uncovered by the Church II. 1955-59 excavation (cf. Fig. 5)

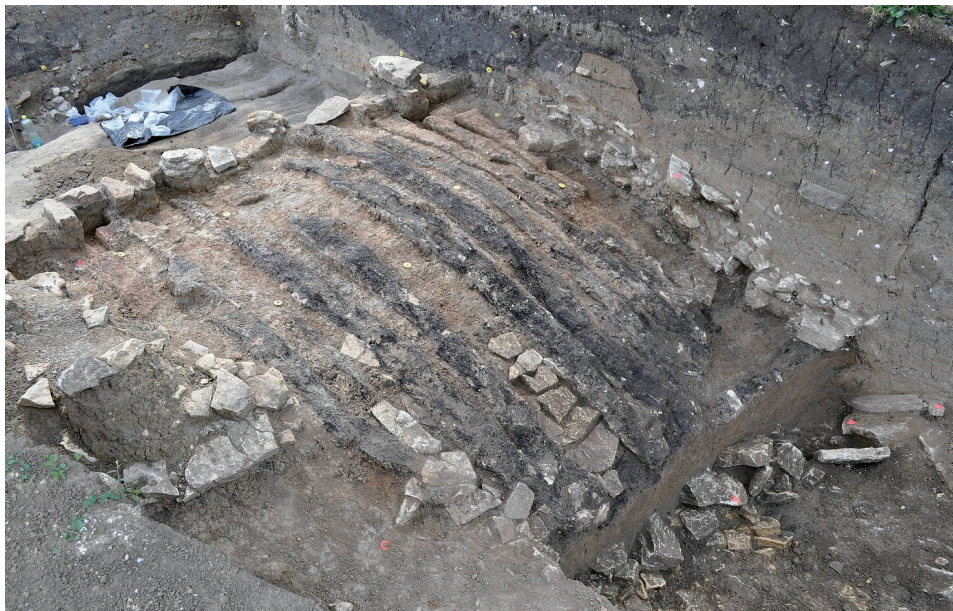
Fig. 19. Mikulčice-Valy, area R 2012 I, II. Overview of the uncovered base of the face wall, standing on a wooden grate over lengthwise laid boards, probe 91 from the NE; the row of stones in the upper-left corner was left in situ – it follows the inner edge of the face wall and shows its thickness at its base. The cross-section prominently shows a modern furnace (see Fig. 18) and a covering layer from the 1950s excavation

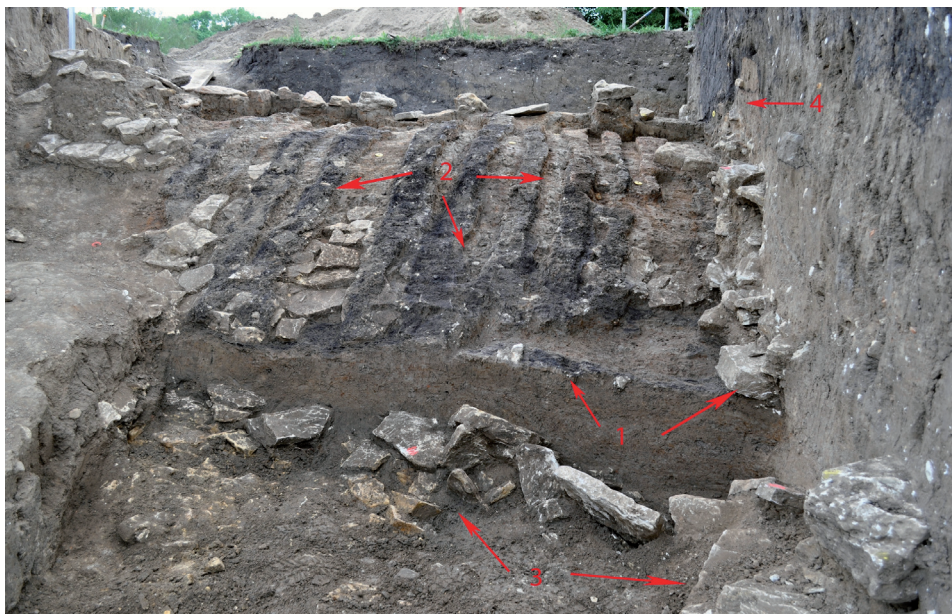
Fig. 20. Mikulčice-Vally, area R 2012 I, II. Detail of the base of the Mikulčice fortification face wall from the N. Legend: 1 – face wall; 2 – base grate; 3 – top of the stone substructure in the beginning of the dig – extension of this structure under the rampart is apparent here; 4 – modern furnace (see Fig. 18)

The stones of the face wall were found to be placed in only three rows in probe 91, but despite this, the foundation of the wall is well established (see Fig. 20, 26, 27). The width of this wall is hard to reconstruct. However, remains of the placed stones point to a width greater than the older excavations revealed (up to 3 m in this section; documentation of other sections mention widths ranging from 1.5 to 2.7 m). The fragmentary preserved portion of the wall in probe 91, disrupted by secondary interventions and mostly dismantled for stone, does not permit even a rough estimate of its height; it is virtually impossible in case of area 96, as it is much less preserved. Given evidence of its dismantling for stone, the height of the wall cannot even be estimated based on the volume of its destroyed remains, because it is impossible to know how much of the stone was secondarily removed.

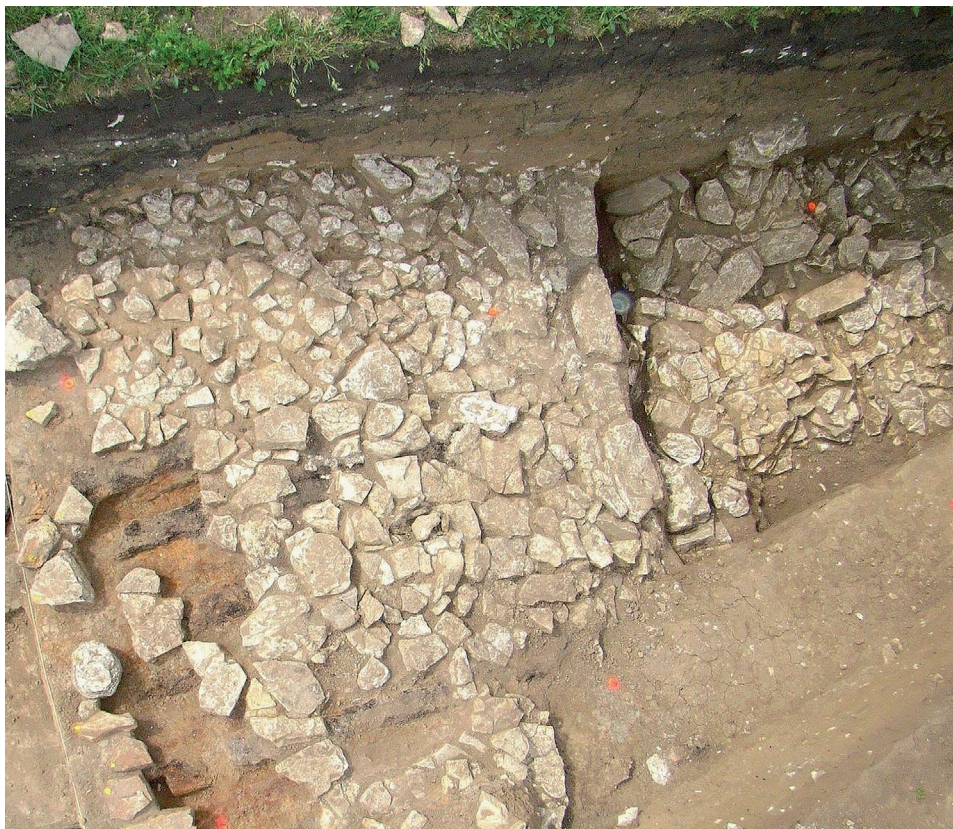
Fig. 21. Mikulčice-Valy, area R 2012 I, II. Photo of the surface of uncovered stone remains in probe 91; face wall in the middle, partially uncovered grate on the left, stones of the sub-structure on the right

The thickness of the face wall, the rampart's stone component, varies according to the documentation between 1.5 and 2.5 m along its length, according to R 2012 sometimes even up to 3 meters (see Fig. 21, 24, 30). However, these figures are measured near the base of the wall, because the upper parts of the wall have not been found in any of the excavated areas. It is very likely that the upper parts of the wall were much thinner than the given figures, a building style similar to one

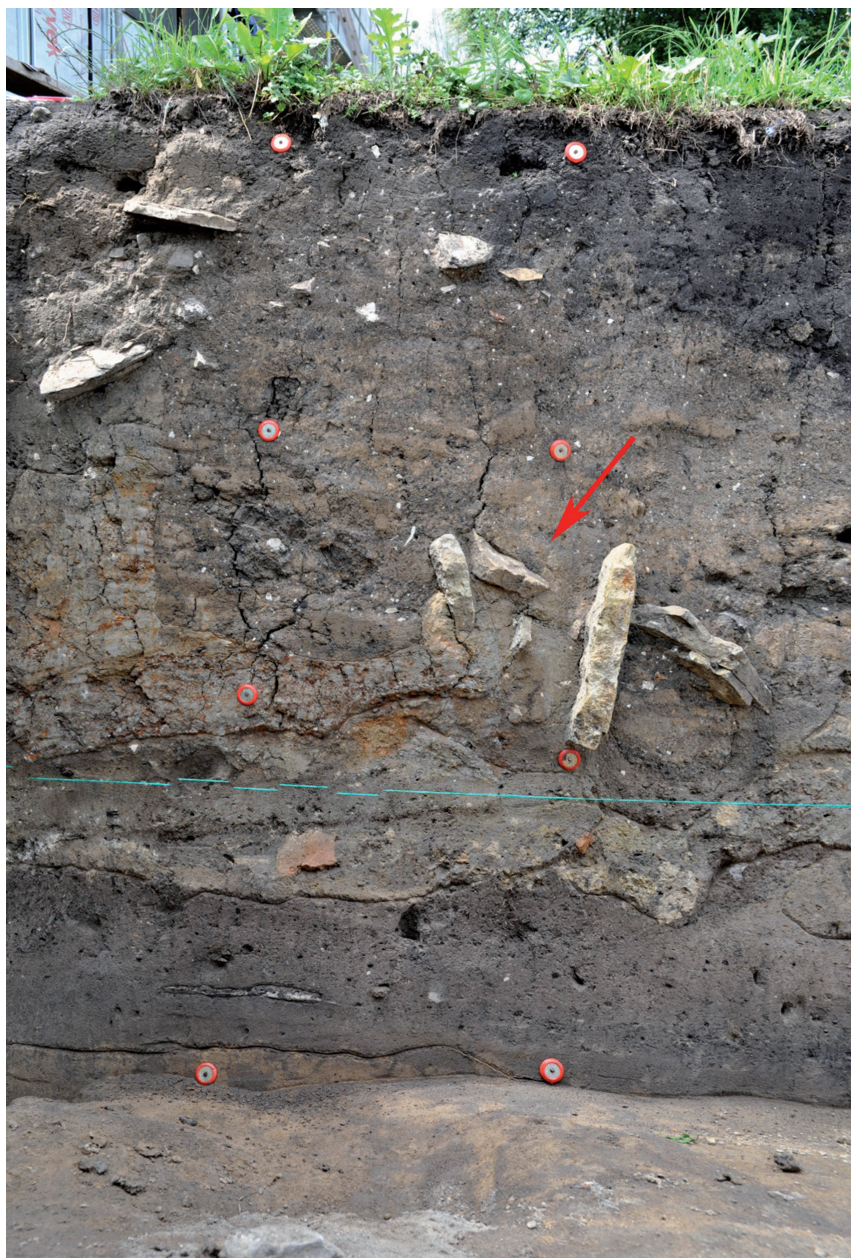
Fig. 22. Mikulčice-Valy, area R 2012 I, II. Stone-lined stake, supporting the stepped back of the rampart core in the main W profile (probe 91). It turns out that the stake hole was not fully explored and was left in situ and buried by the 1950s dig. This hole was cut in half during the mechanical removal of the undocumented covering material in the W part of the new excavation (cf. Fig. 23)

planks of the base grate (Fig. 22, 23, 24). The distance between the stakes and the face of the rampart is about 6 m. This raises the question whether the core had a „step” there in the back, held possibly by a plank wall supported by the buried stakes. A charred beam was found, oriented parallel to the imaginary line connecting the two discovered holes⁸, left by the stakes, found in the lowest sandy

⁸ The first hole, lined with vertically placed stones, was uncovered in the main W profile of the excavated area (Fig. 22). It was apparently left unevaluated on a shelf in otherwise removed terrain from the 1959 excavation and reburied without any documentation (either in the drawing of the containing grid square, or in a written description). The second hole was found in the previously undisturbed terrain of probe 96, on the other edge of the excavated area, in the E profile (it is actually two stakes side by side, lines with stones, see Fig. 23). Given the significant 5.5 m distance between them, and the finding that the whole southern side of probe 91 was excavated in 1959 and only poorly documented, it is probable that another hole on the line between the other two was unrecognized, or was „at least” not documented or left *in situ*.

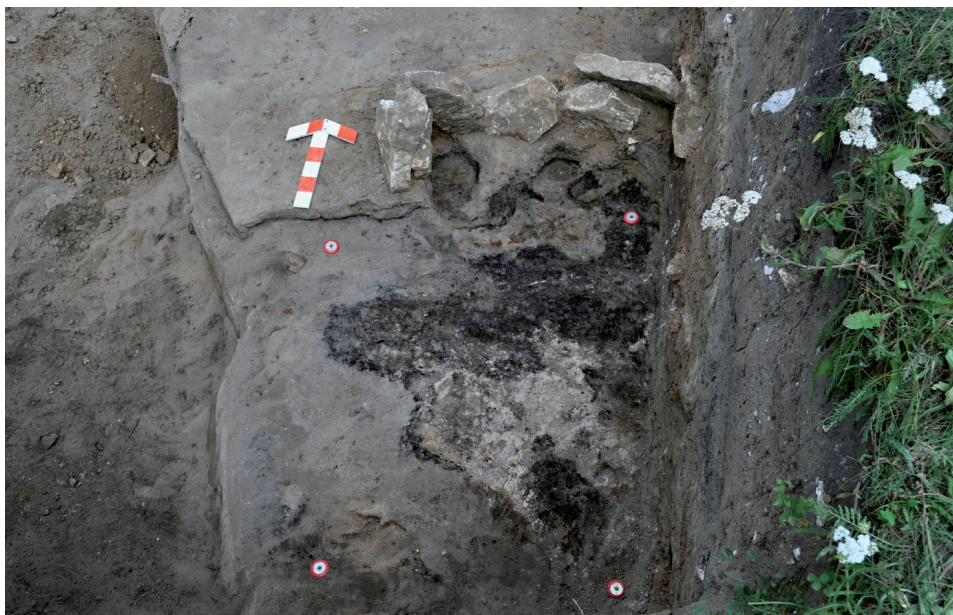
Fig. 23. Mikulčice-Valy, area R 2012 I, II. Lining of two stakes supporting the stepped back of the rampart core near the E profile (probe 96), viewed from the S

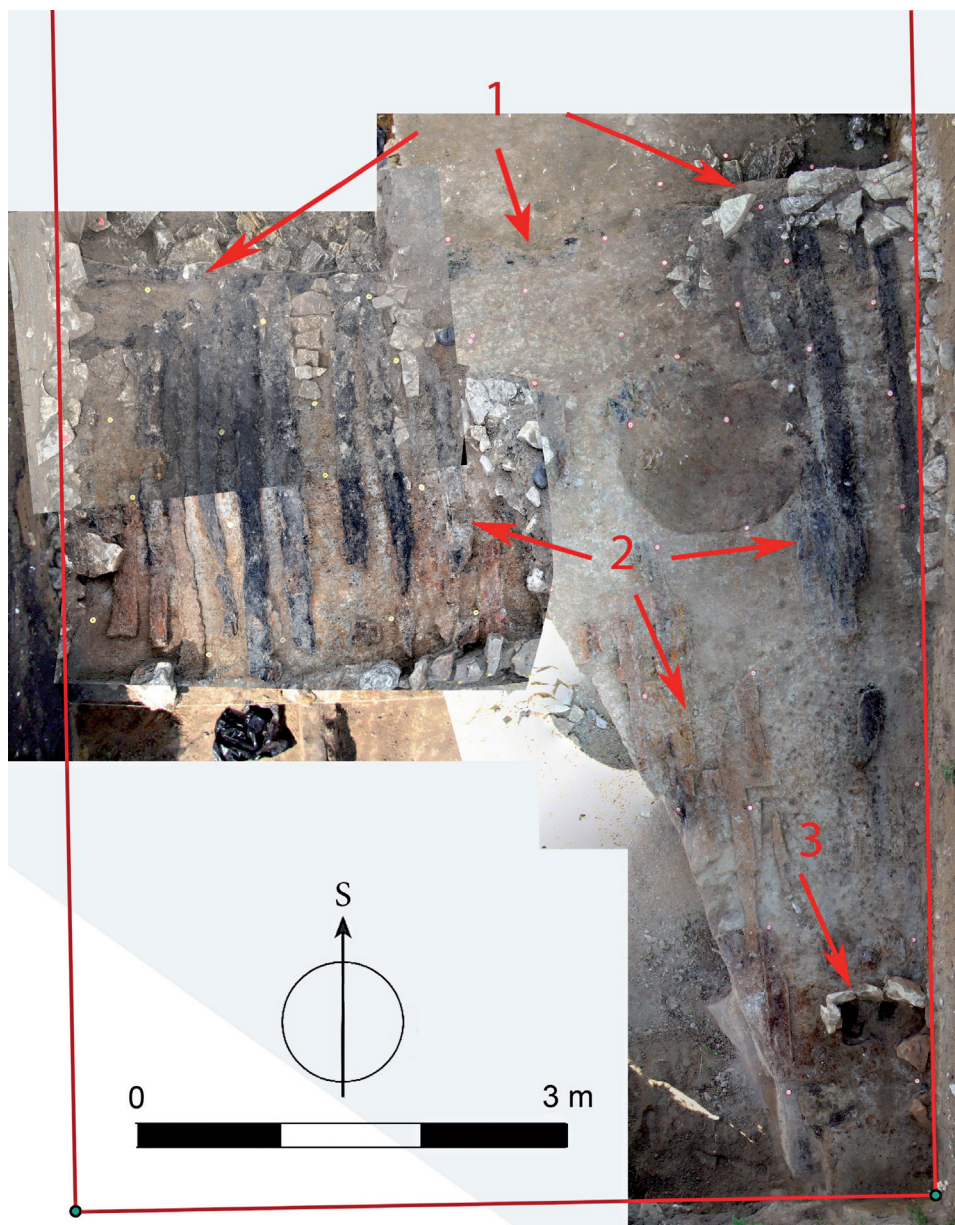
Fig. 24. Mikulčice-Valy, area R 2012 I, II. Overview of the remains of uncovered wooden grate in probes 91 and 96 (red line is the excavation border). Legend: 1 – lengthwise placed boards under the face wall; 2 – transverse base grate (the photograph highlights the contrast between the burnt and unburnt boards); 3 – two side by side stone-lined holes (see Fig. 23 – the back of the stepped core?); in the SW part, in probe 91 (blank space), the wood of the grate was removed by the 1959 excavation (cf. Fig. 5)

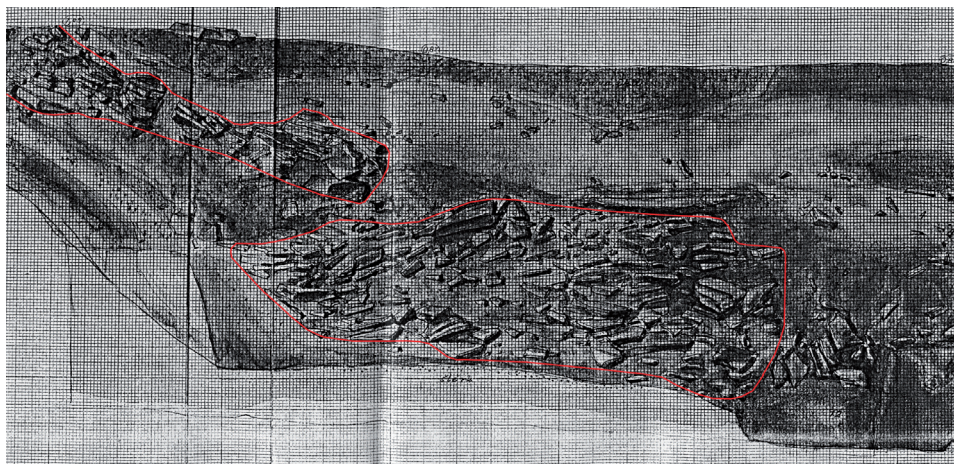
Fig. 25. Mikulčice-Valy, area Church II. 1955-1959. The only documented cross-section of the rampart with documented stone structures in this excavated area between C0 and D0. The remains of the pressure-deformed face wall and substructure are highlighted in red.

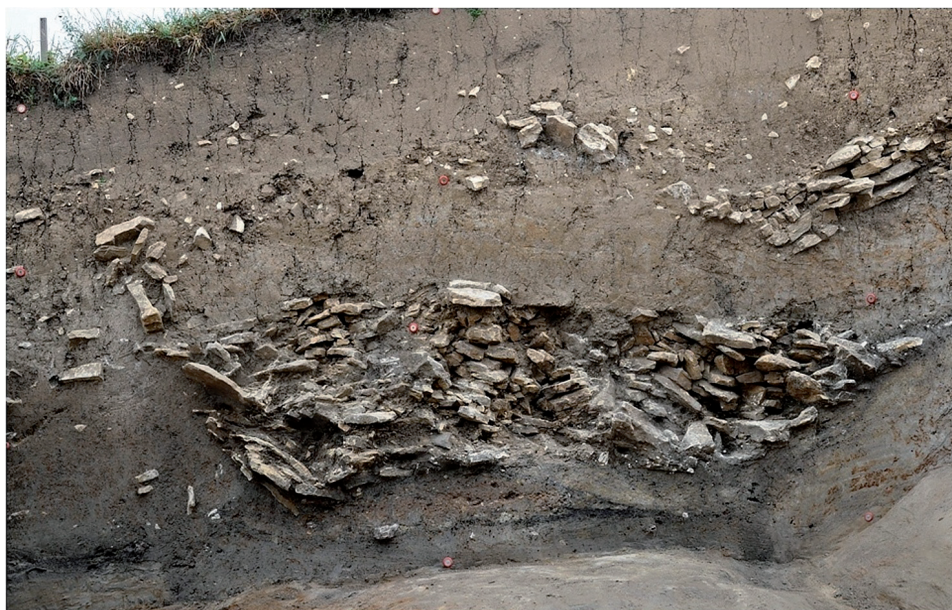
Fig. 26. Mikulčice-Valy, area R 2012 I, II. Cross-section of the stone substructure with a stake hole in the front (left), which belonged to one layer of the three layer palisade; main E profile of probe 96. The upper-left corner contains the deformed base of the face wall (cf. Fig. 25, 27)

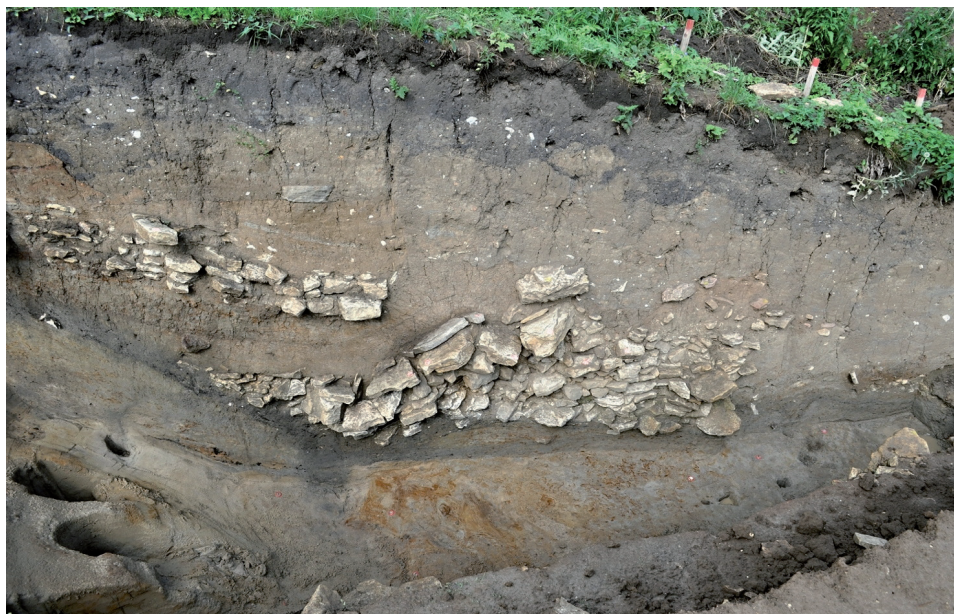
Fig. 27. Mikulčice-Valy, area R 2012 I, II. View of the stone substructure, main W profile of probe 91. Face wall on the left, whose weight deformed parts of the substructure (cf. Fig. 25, 26)
