FINDINGS ABOUT THE EARLY MEDIEVAL FORTIFICATION OF THE MIKULČICE – VALY ACROPOLIS

Abstract: The author evaluates the available information about the fortifications of the Mikulčice acropolis, the main area of the Early Medieval agglomeration. He gives a new perspective on the structure and dating of the fortification based on analyzing the documentation of all conducted excavations. Great Moravian rampart is composed of a stone face wall, clay-wood core strengthened by grates and a stone substructure ringed by stake palisades, in front of, and in some places partially under, the face wall. The substructure's role was most likely to bear the face wall's weight and to strengthen the artificial slope under it against water erosion by the nearby river. The defensive wall was built in a relatively short time as a singular structure, probably in the last third of the 9th century.

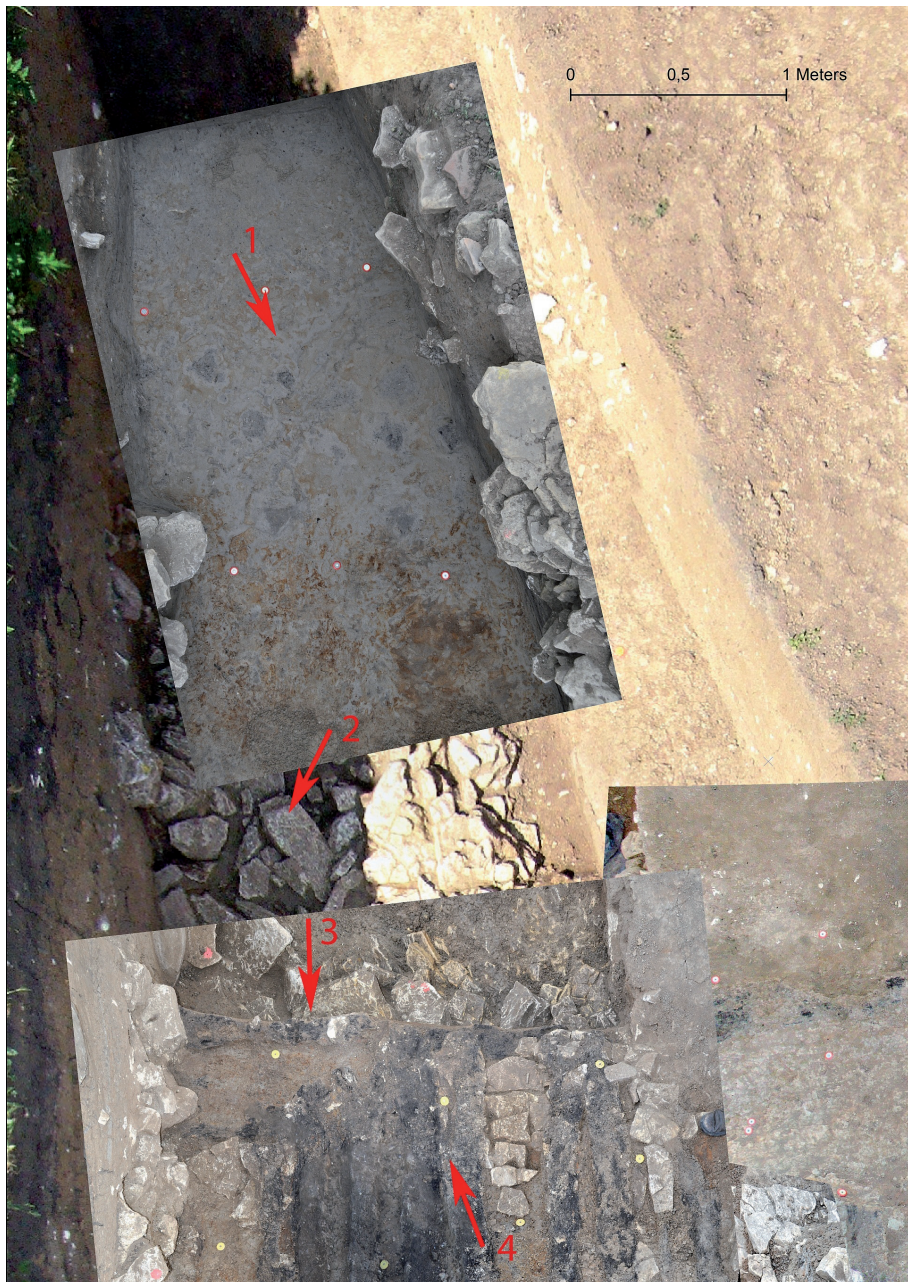
Fig. 28. Mikulčice-Valy, area R 2012 I, II. Combined photos give an overview of the front (outer) part of the fortification in probe 91

Part of this substructure, placed right in front of it, are three layers of stake palisades (for placement of these layers into the greater context, see Fig. 28). The archeological excavation proves in all cross-sections that the face of the lower stone substructure leaned on these stakes, which were able to stand for a long time after the demise of the power center as shown by the fact that it did not sprawl outward (it only leans outward), as if it continued to lean on the stakes (see for ex. E profile of area 96 – Fig. 26). The stakes were already found in the two lower contexts, but they could only be spatially distinguished in the gravel subsoil, where the lower few centimeters of their spiked ends were imprinted (in some contexts, they could not be distinguished at all – maybe due to post-depositional processes and river action after the settlement or its wall was no longer in use). The imprints show that the spikes had triangular and diamond cross-sections. That the spikes were edged and not conical shows, that they were meant to be driven into gravel, because it is almost impossible to drive cones into it. Length-wise cross-sections show that the spikes quickly widened, so the stakes had to have been relatively massive, and given the short distances between them, driven side by side. The stake layers have almost the same distance from each other as the stakes themselves, which makes this a three-layer palisade, offset before the front

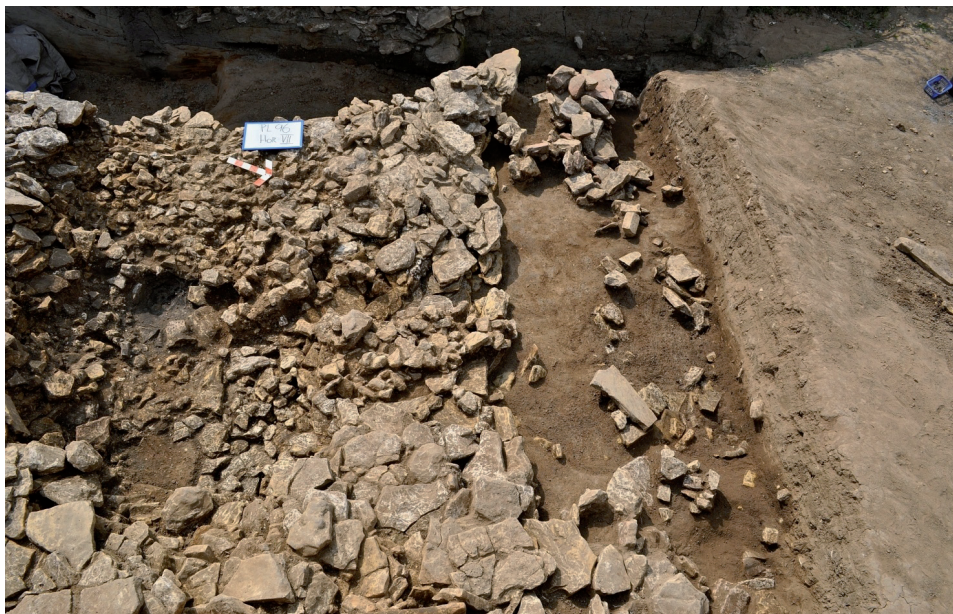
Fig. 29. Mikulčice-Valy, area R 2012 I, II. Overview of the uncovered stone substructure in probe 96, from the E. The documented situation after soil removal; the captured state of the structure shows the significant disruption due to stone removal in the early Modern era. The photo documents the front of the substructure, which formerly leaned against a multilayer palisade (cf. W profile of the excavation in the background). The destroyed remains (evidently from the face wall) in front of the substructure contain imprints of some of the palisade stakes (still upright when the fortification was destroyed).

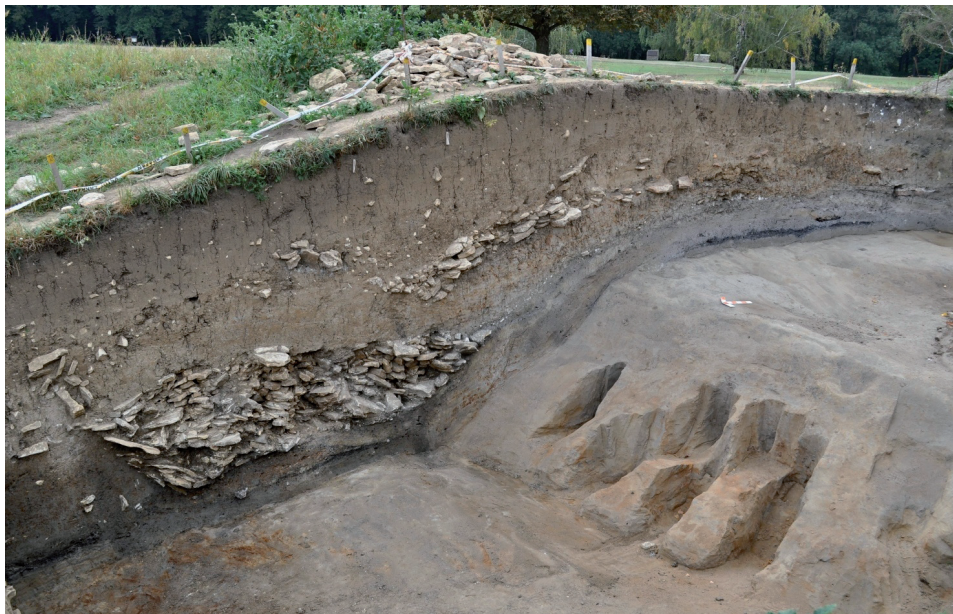
Fig. 30. Mikulčice-Valy, area R 2012 I, II. Overview of the finished excavation from the NW. The slope on the right shows signs of stake holes removal, found under the face wall and all the rampart core layers

The thickness of the face wall, the rampart's stone component, varies according to the documentation between 1.5 and 2.5 m along its length, according to R 2012 sometimes even up to 3 meters (see Fig. 21, 24, 30). However, these figures are measured near the base of the wall, because the upper parts of the wall have not been found in any of the excavated areas. It is very likely that the upper parts of the wall were much thinner than the given figures, a building style similar to one

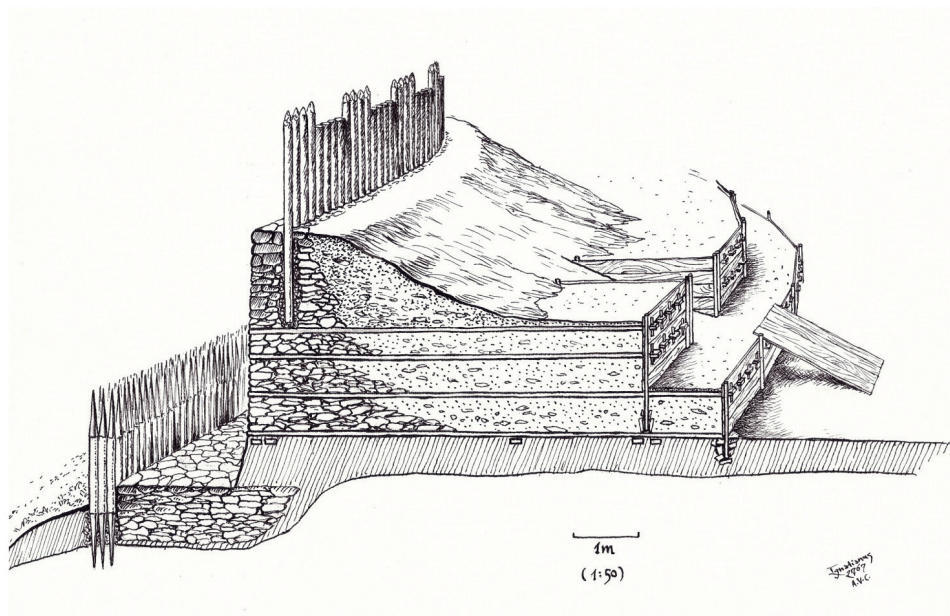
Fig. 34. Mikulčice-Valy. Newly created reconstruction of the rampart in the NW section of the Mikulčice acropolis fortification, near church II.
